GROYNE TO PREVENT RIVERBANK EROSION ON MEKONG RIVER

Hirotsada MATSUKI, Dr.Eng.

Ministry of Land, Infrastructure, Transport and Tourism (1997-2000 JICA Expert for Laos)

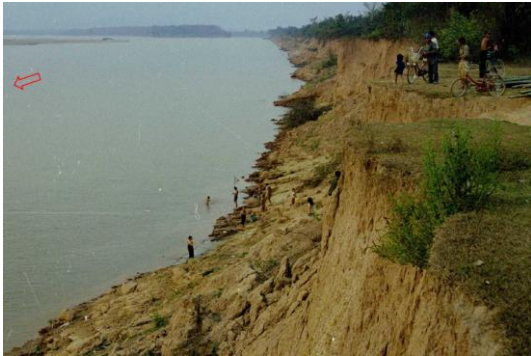
The eroded bank kept a sheer cliff of about 10 m heights with no vegetation due to half-year

submergence and soil displacement (Photo 1).

Photo 1 3km-long riverbank erosion (February 1998)

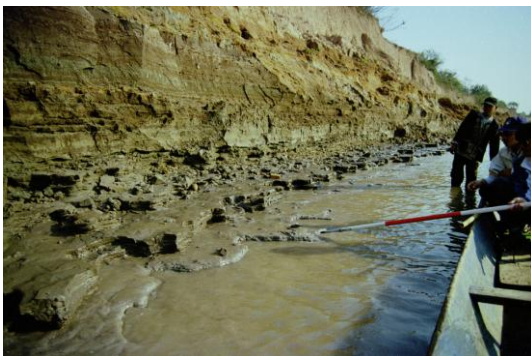
The cliff consisted of diluvial layers and had deeply laterized. On mudstone section, non-disturbed bedrock was not solid in wet condition enough to be scooped by a finger (Photo 2). Cobble section on upstream part was covered by 10cm diameter materials (Photo 3), which had come out of the diluvial layer because the Mekong tractive force could not force them to move. The opposite point bar of 0.1 mm fine sand covered a half of the cross section of Mekong.

Photo 2 Laterized muddy rock (February 1998)

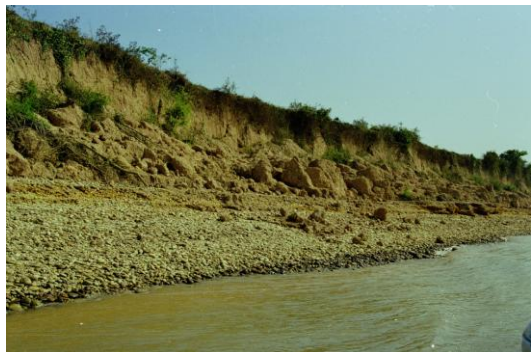
Photo 7 Cobbles on the eroded riverbank (February 1998)

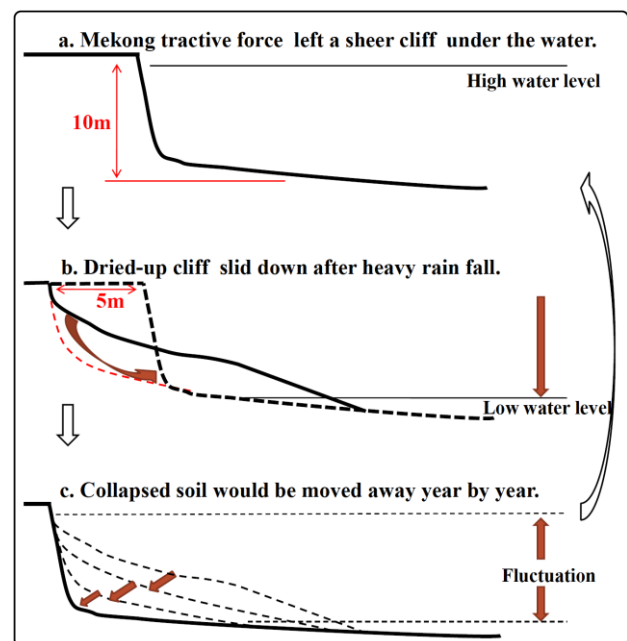
Fig. 3 Cyclic erosion in monsoon fluctuation

The findings indicated that the progressive erosion was triggered by circular slip which has around 5-year return period. Then the author made a hypothesis of a cyclic erosion illustrated in **Fig.4**. This could be explained as a compound effect of the diluvial bank strata and dynamic fluctuation.

At a concave bank of a river meandering, tractive force of a spiral flow works on both riverbank and riverbed. Especially in high-water seasons, stronger sweeping stress removes smaller particles away leaving larger materials and undisturbed diluvial layers. Yearly repeating fluctuation of Mekong results in the formation of a 10m sheer cliff under the water.

The cliff will emerge in the next low-water season. The open-air cliff is stable and dried up due to arid climate. In coming of the next rainy season, a heavy rain on the top of the bank is able to upset the gravity balance to cause a circular slip. Then the bank retreats approximately 5 meters. The collapsed soil clump accumulates at the foot of the cliff to stabilize the remaining bank.

When the river rises again in high-water seasons, the collapsed soil clumps are submerged with less solidity. That will be easily swept away little by little. The tractive force will reform a 10m cliff at 5m set-back position in approximately 5 years.

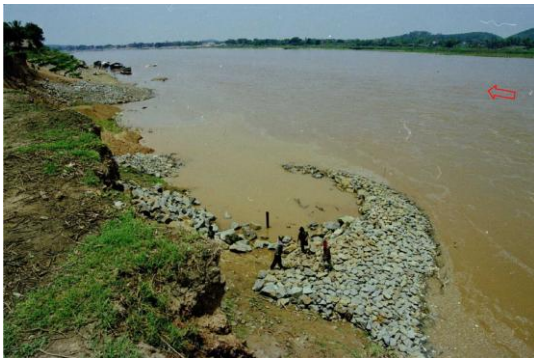
Photo 5 No.1 and 2 masonry under construction (May 1998)

Lao government got started the test construction in February 1998. The first masonry was set at 200m point from the boat stop. During the low water season, 30-70cm diameter granite transported from the hill quarry were laid out in a circle and piled up to make a 6m-high impermeable base by backhoes and workers (**Fig. 5**).

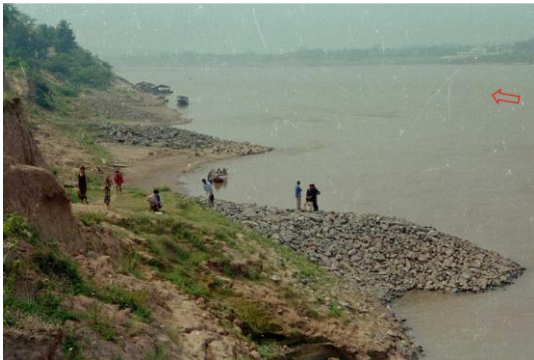
- no sinkage of rock materials and no deformation on the masonry during 2 high water seasons
- initial deposition between masonries
- willow rooting on the masonry No. 2 by itself
- 2 months construction period for 1 masonry
- 30,900 USD for 1 masonry, equal to 309 USD to cover 1m riverbank at an average cost

Photo 6 No.1, 2, 3 and 4 masonry completed (April 2000)

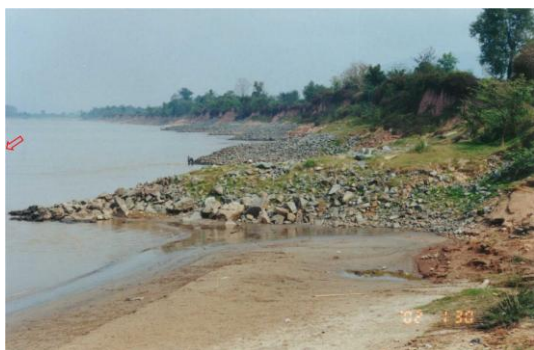
Photo 7 Masonries and deposition (January 2002)

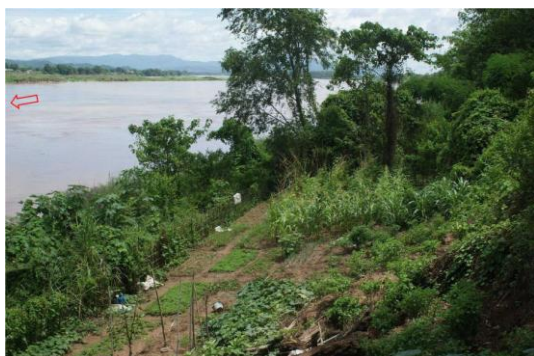
On the 20 masonries, little deformation was found and natural vegetation had been growing. No. 1 masonry, especially, was entirely veiled by green trees. The masonry was fixed by their roots and functioned as a concealed resistance (**Photo 8**). Calm water zone was created between No. 2 and

Photo 8 No. 1 groyne concealed by vegetation (June 2010)

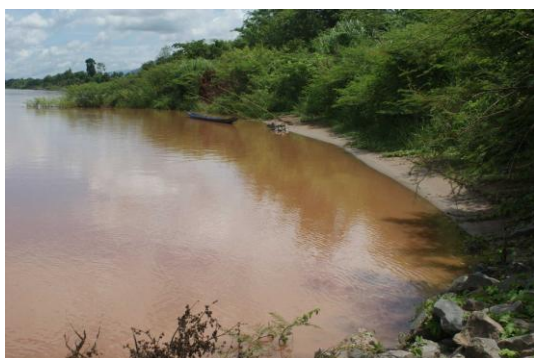
No. 3. In this section, a thick sand sediment up to the masonry's crest level shaped a simple arc (**Photo 9**). A young willow had just taken root on No. 11 and would invite other vegetation to make the groyne stronger (**Photo 10**).

Photo 9 Calm water between No. 2-3 groynes (June 2010)

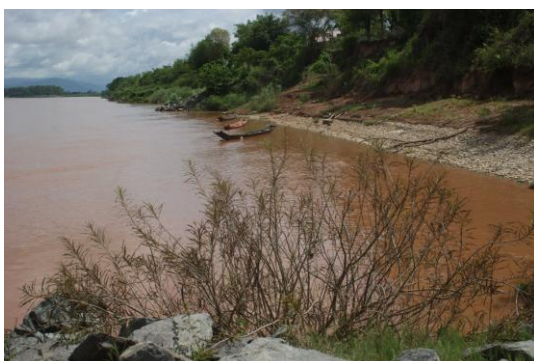
Photo 10 Mekong willow on No. 11 groyne (June 2010)
