Fukui Torrential Rain in July 2004

- Kinki Regional Development Bureau, Ministry of Land, Infrastructure and Transport and Fukui Prefecture: *Disaster by Fukui Torrential Rain in July 2004 (prompt report)*

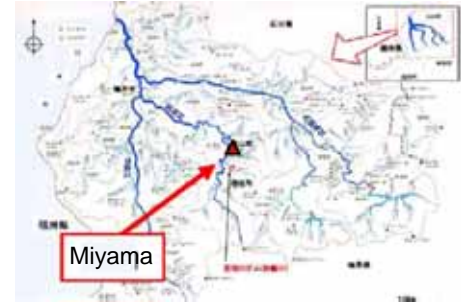
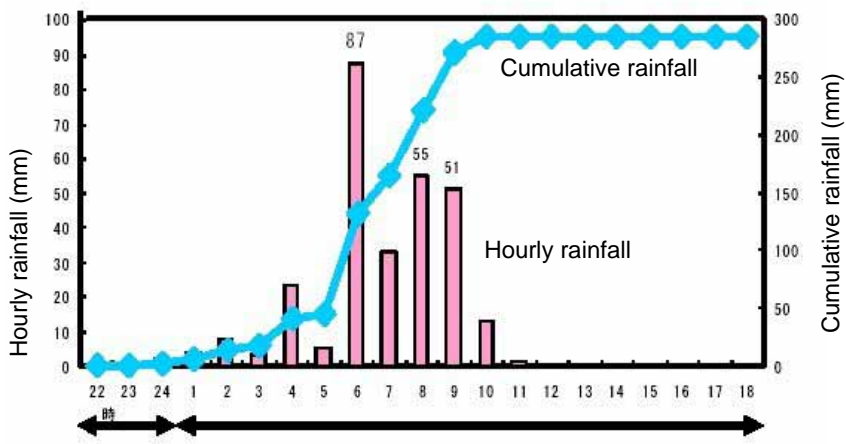
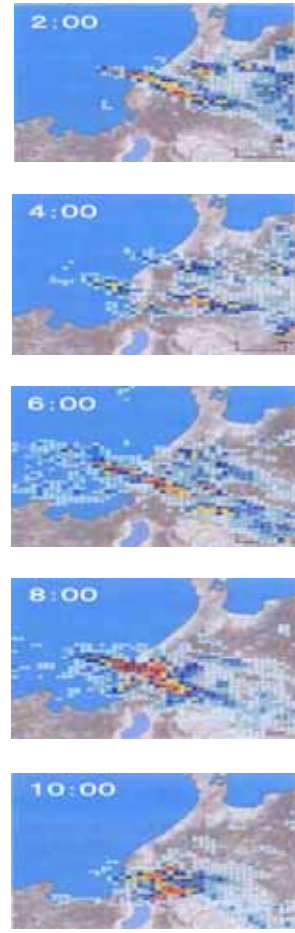
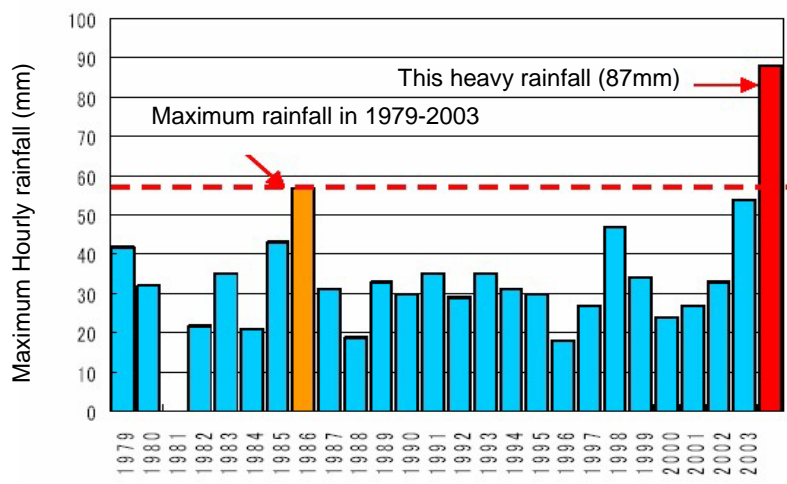
Radar rain gauge

Baiu-front¹⁾ extending from Japan Sea to Hokuriku district (Fukui Prefecture) became active, and thick nimbus clouds covered Hokuriku District of Fukui Prefecture. It rained heavily especially in Reihoku area of Fukui Prefecture from the dawn of 18th until noon. Miyama Town had the record amount of rainfall 285mm in total from the beginning of rainfall.

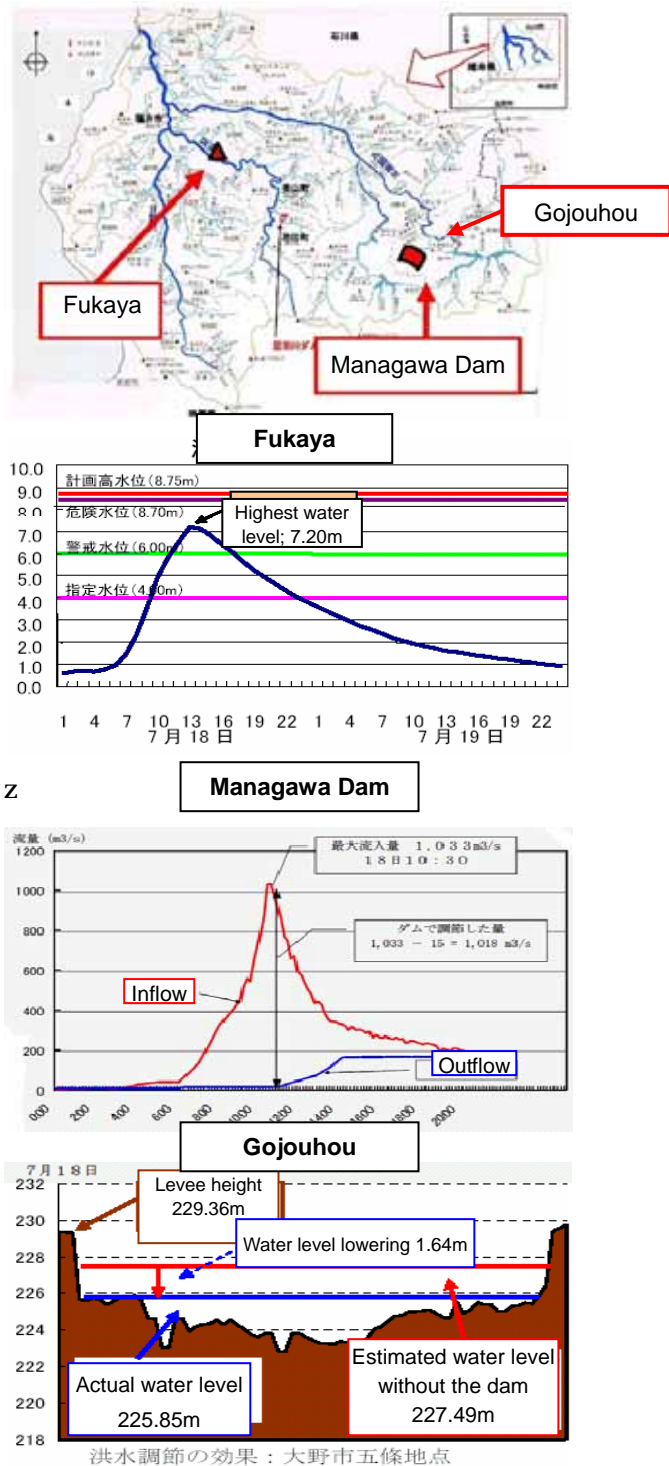
The dam regulated flood flow and the difference between inflow and outflow was about 1,000m³/s at the maximum, and it lowered the water level of the downstream.

Without the dam, it is assumed that the water level might have reached just 1.87m below from the levee crest at Gojohou in Ono city (The highest water level recorded: was 2.35m at 16h00 of 18th).

The dam contributed to bring the water level down by about 1.64m.

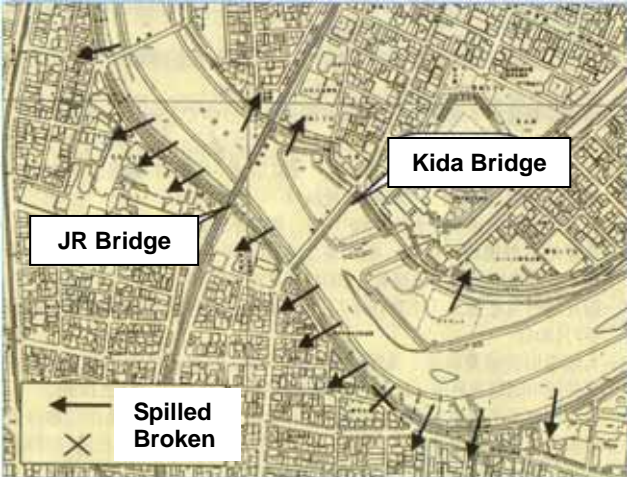
Most damage of Fukui torrential rain was caused by water spilled from a levee or flow from a broken dyke. Especially, the heaviest rain in the recent years caused flood near the JR Bridge and the Kida Bridge in Fukui city, and brought about a lot of damage in the city (According to the analysis by the urgent research of Japan Society of Civil Engineers in July, 2004, the decrease of cross-sectional area by bridge piers is assumed to be the cause of the spill and the dyke break).

Spots of the spill from the levee and the levee failure.at JR bridge and near Kida bridge

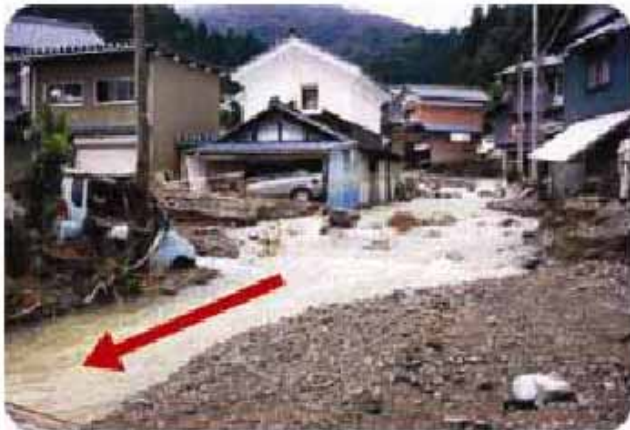
Debris flow

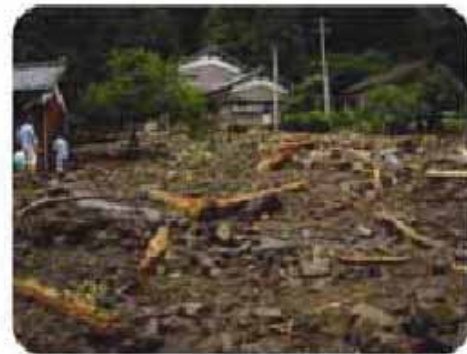
Debris flow

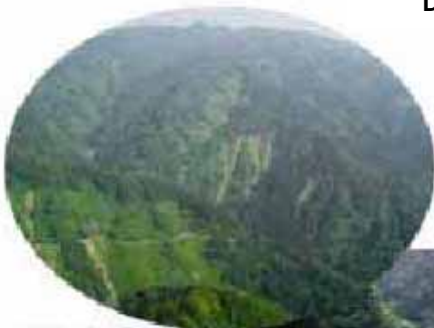
福井市一乗谷川源流付近
崩壊箇所が複数見られる

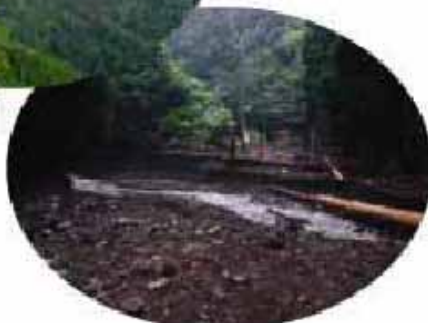
Debris flow

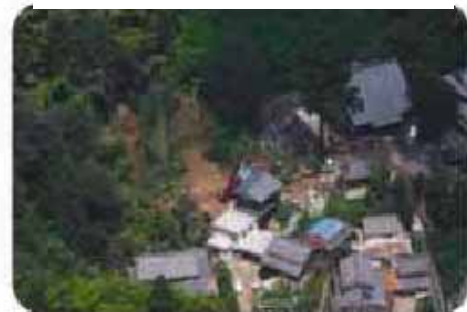
Landslide

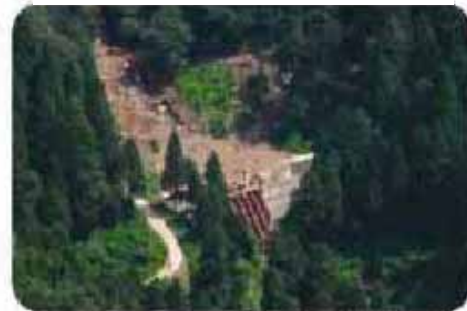
Sedimentation and floodwood

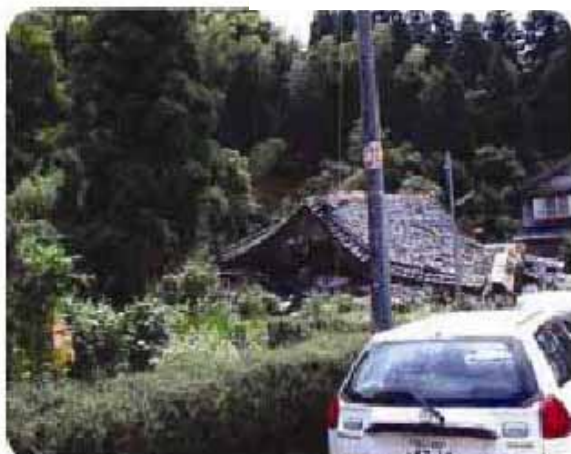
Landslide

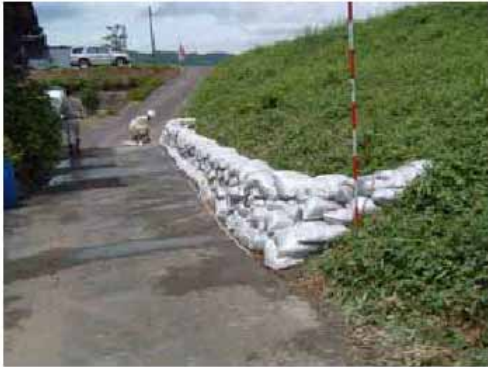
Shimizuchou, Katakasu : water leakage at the left bank of Hino River

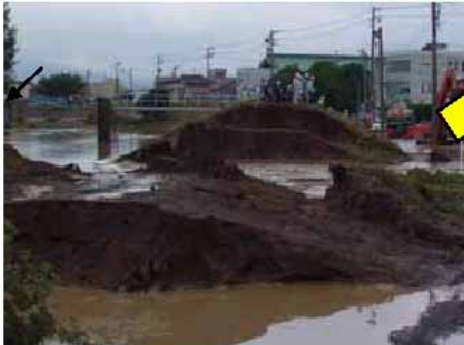
Dyke breaks (Asuwa River in Fukui district)
