# Niigata-Fukushima Torrential Rain in July 2004

# 1. Meteorological phenomena and precipitation

## 3. Damages

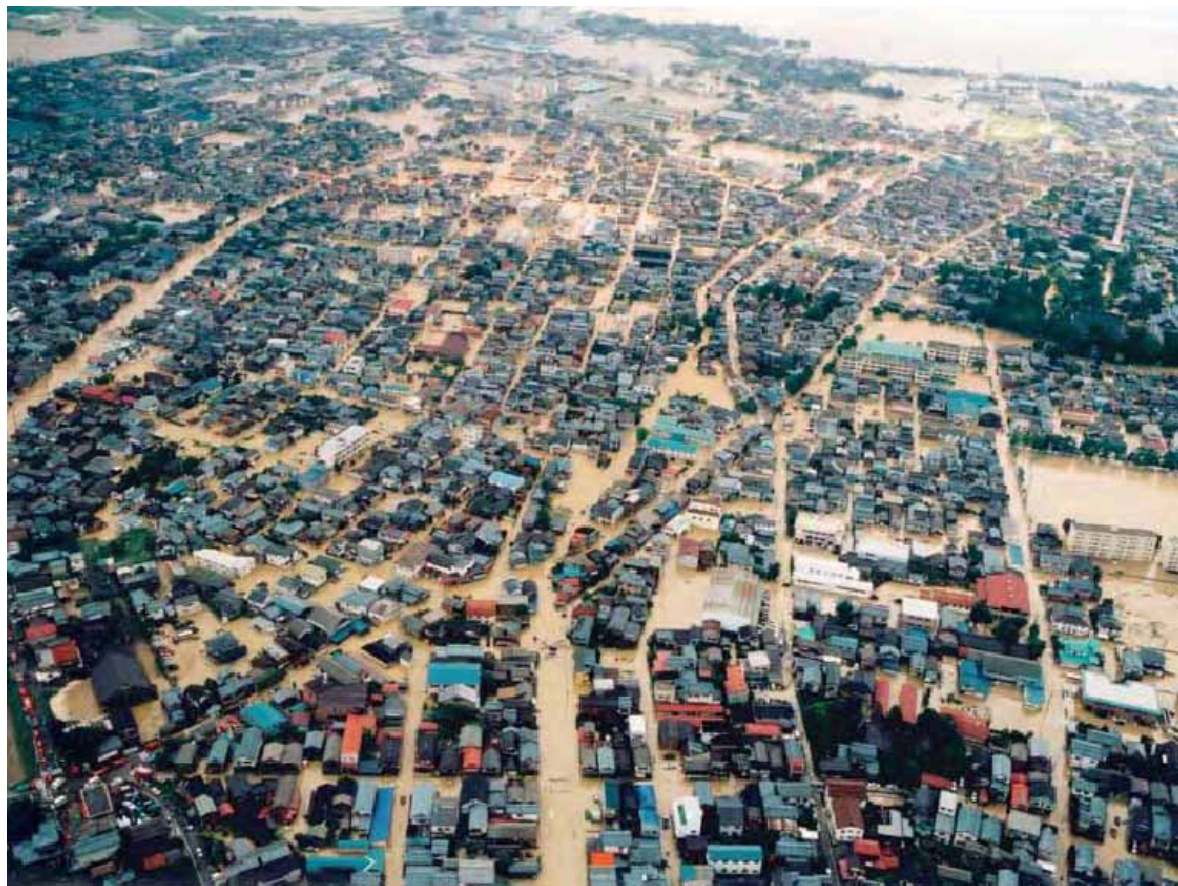
Inundation in Sanjo-City

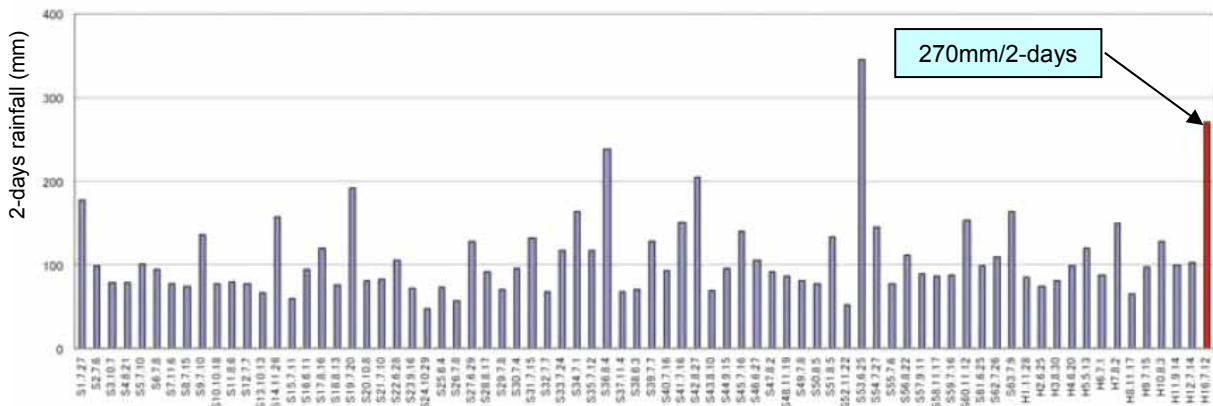
Maximum annual precipitation for two days at the average precipitation  
in the lower stream of Shinano river basin

The basins average 2-day rainfall over upper stream area from Teisekibashi reached around 270 mm. This was the second largest rainfall after World War II following 335 mm in two days, recorded in June 1978 and nearly equals to a 150-year rainfall in this basin.

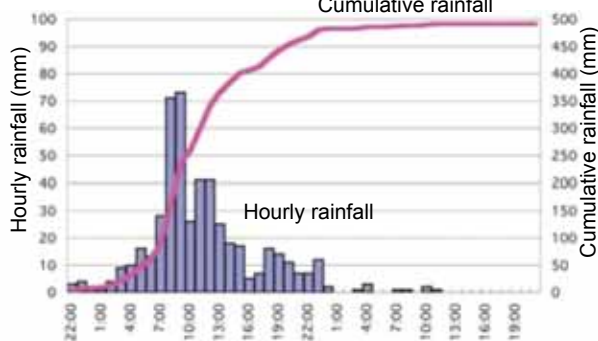
**Kasabori Dam** Total precipitation: 489mm  
Cumulative rainfall

It was the regional heavy rainfall that has ever been experienced, as total precipitation from 12 to 14 July at Kasabori-dam and Kariyatagawa-dam were 489 mm and 433 mm respectively.

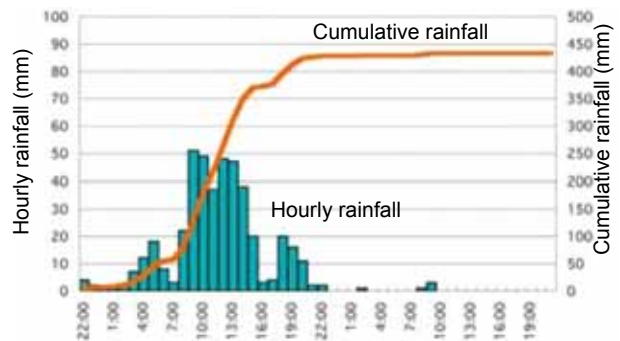
**Kariyatagawa Dam** Total precipitation: 433mm  
Cumulative rainfall

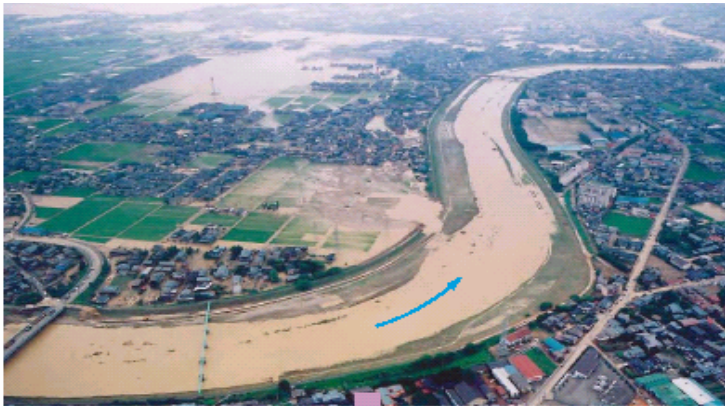
Broken point of the embankment

Most of the damages were caused by dyke breaks. The dykes at Suwa area in Sanjo-City along the Ikarashi River and at Nakanoshima area in Nakanoshima-Town along the Kariyata River were breached, and most of the deaths and the housing damage occurred in these areas.

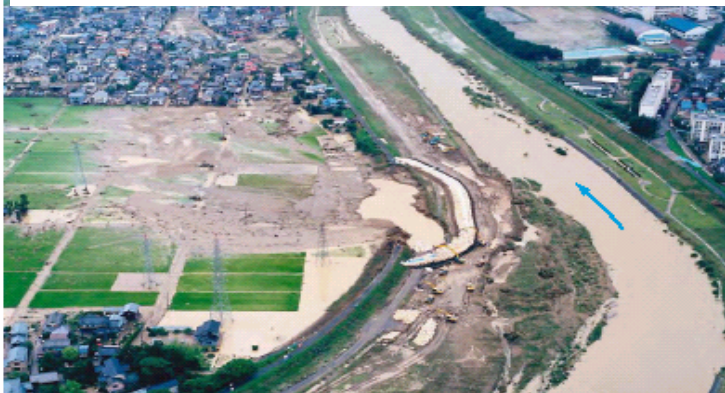
Restoration work from disaster

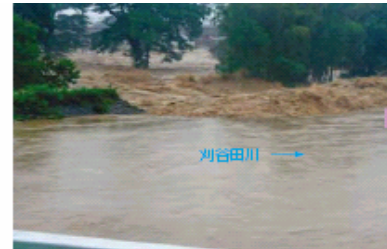
Kariyata River

Broken point of the embankment

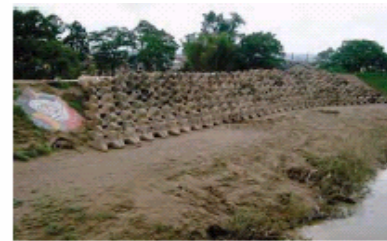
Restoration work from disaster

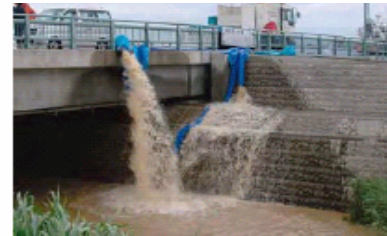
Pumping drainage

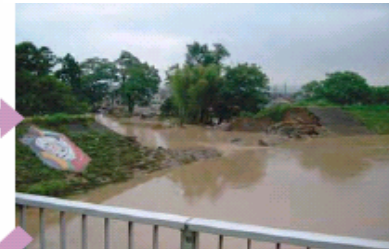
Broken point of the embankment

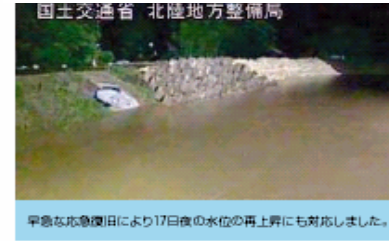
Broken point of the embankment

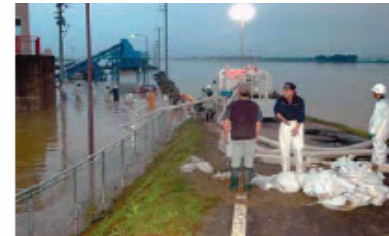
Flood fighting activity
