# Report on Preliminary Study of the Elbe River Floods

September 12, 2002

Infrastructure Development Institute  
IFNet Preparatory Unit, "Water in Rivers"

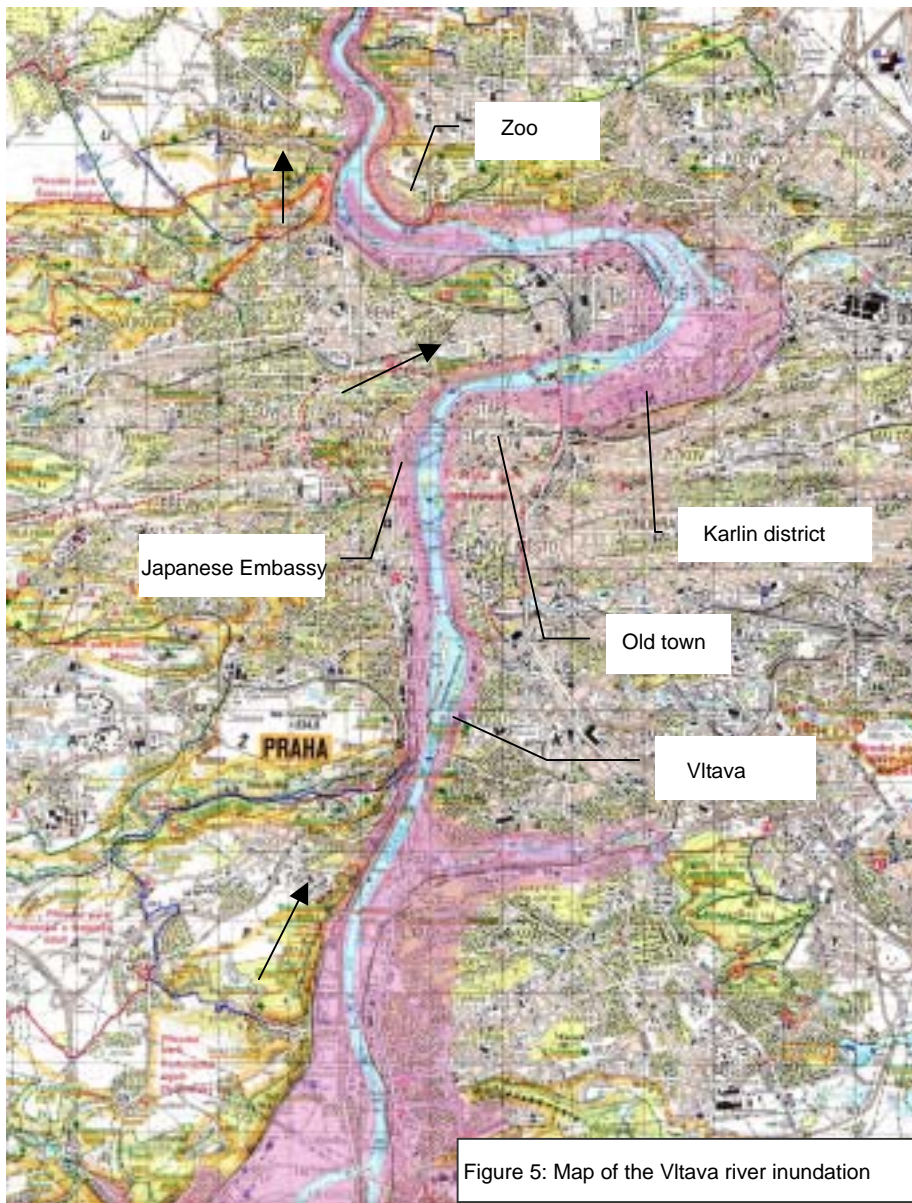
Explanation of Figure 5  
Inundated area within Praha City  
(Source: Japanese Embassy in The Czech Republic)

However, low-lying land other than the old town including the heart of the city such as the government office area on the opposite side of the river, where the Japanese Embassy is located, and shopping areas, electric appliance shop areas and hotels in the Karlin district downstream were submerged

under 3m of water in some places and damaged severely. In addition, reverse flows from the drainage system inundated basements in an extensive area stretching beyond the old town.

(See Figure-5)

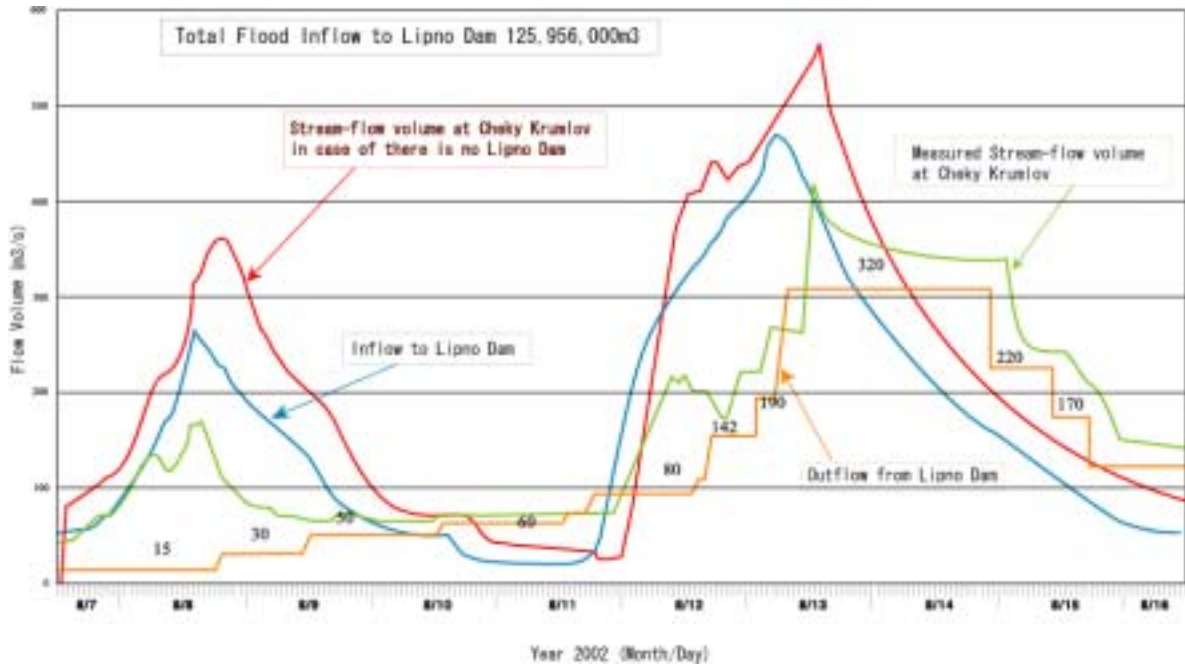
Figure 5-3 : Outflow from Linpo dam and Stream-flow Volume of Chesky Krumlov City

Figure 5-3 is the flow-rating curve, which shows inflow and outflow of Lipno dam, and stream-flow volume of Český Krumlov City located downstream of the river. The figure shows the following three points:

- a.  $320\text{m}^3/\text{s}$  was discharged at the Lipno Dam, which was reduced by  $150\text{m}^3/\text{s}$  from the maximum inflow ( $470\text{m}^3/\text{s}$ )
- b. Then the stream-flow volume of Český Krumlov City was hold at  $410\text{m}^3/\text{s}$ , not at  $560\text{m}^3/\text{s}$
- c. It is estimated that the stream-flow volume was more than  $5,000\text{m}^3/\text{s}$  during the

flood in Praha. Since there was only 320m<sup>3</sup>/s discharge volume (maximum capacity) at the Lipno dam, the influence was extremely small.

Therefore, the Lipno dam contributes for the retaining water with the amount of 150m<sup>3</sup>/s to mitigate the downstream flooding in Praha.

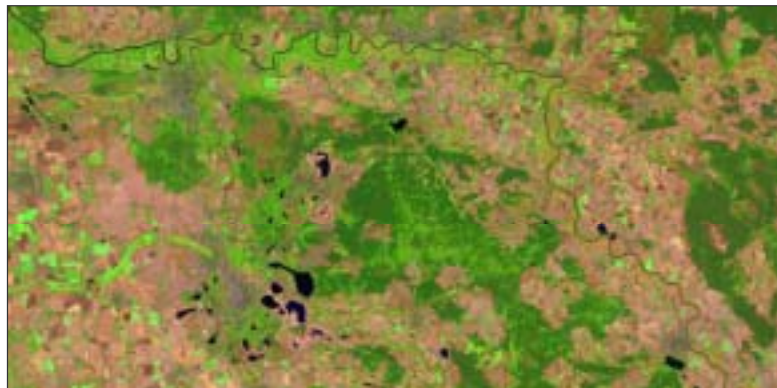
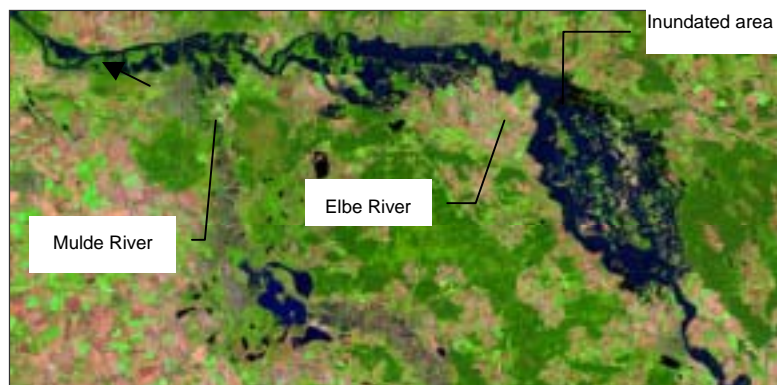
Figure 6: Satellite photo of the Elbe river: an inundated area downstream of Dresden

The river forms a gorge upstream of Dresden, but its valley widens downstream of Dresden, where it flows in the confines of an embankment. Since the embankment in this section was constructed to a probability of overflow of once in 100 to 200 years, the banks on both sides of the river were broken in the section from about 60 km downstream of Dresden to the Elster River junction (about 120 km downstream of Dresden), inundating an area of 300 km<sup>2</sup>. The right bank of the Mulde River was also broken just before its junction with the Elbe River.

August 14, 2002

August 20, 2002

The water level was lowered by 50 cm in Wittenberg as a result of the embankment washouts and by 40 cm in Wittenberg by artificial flow regulation. (See Figure-6, 7, 8, 9)

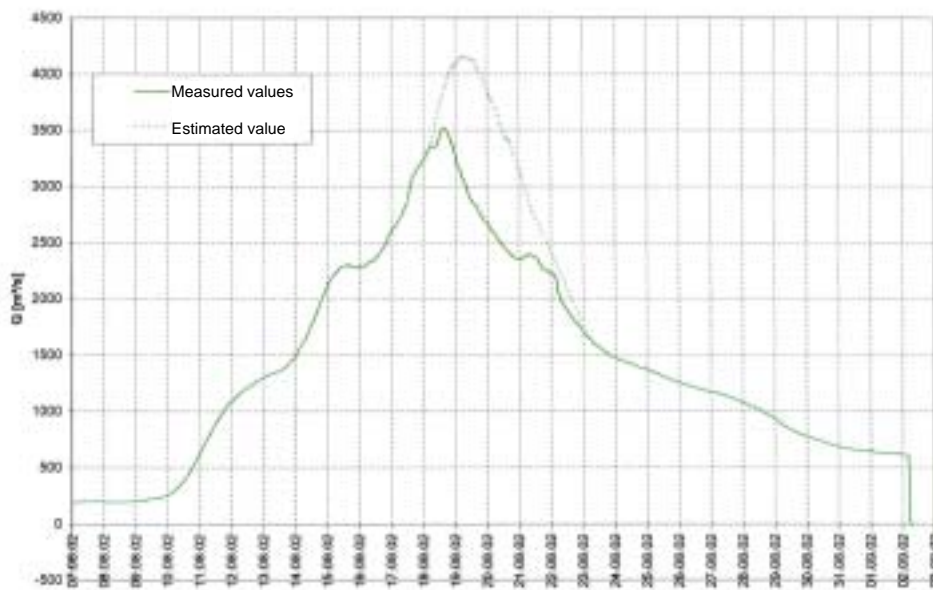
Figure 7: Flow rate observation data (Wittenberg)<sup>2</sup>

Explanation of Figure 7: Flow rate chart at Wittenberg

As a result of the washouts of the Elbe River's embankments, the flow rate lowered from 4,100 m<sup>3</sup>/s to 3,500 m<sup>3</sup>.

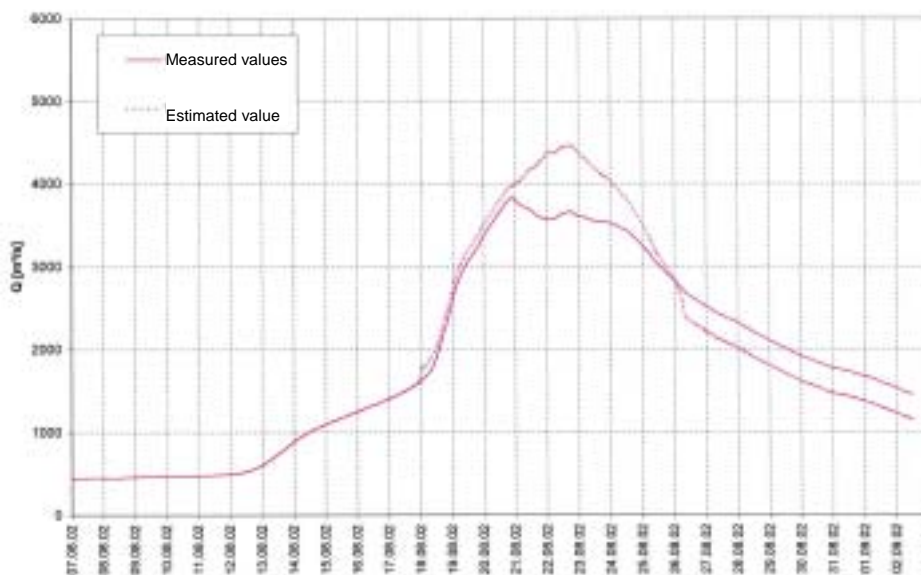
Figure 8: Flow rate observation data (Wittenberg)<sup>2002</sup>

Explanation of Figure 8: At Wittenberg, the flow rate lowered by  $650 \text{ m}^3/\text{s}$  as a result of the dam's flow regulation.
