米国中西部（イリノイ州、ミズーリ等）洪水による被害

場 所	米国 イリノイ州、ミズーリ州等	死者※	24名
発生日	2015年12月26日	行方不明者※	0名
概 要	12月26日ごろからの米国中部での豪雨により、ミシシッピ川水系で洪水が発生。

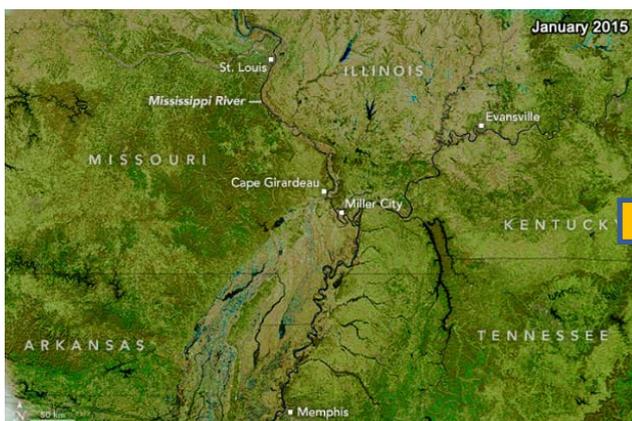
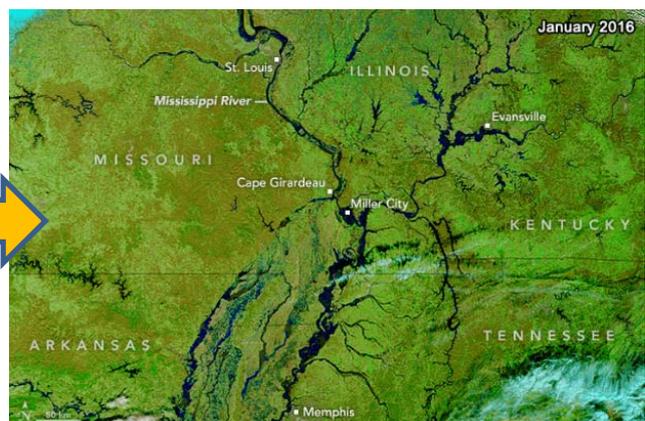
(セントルイス～メンフィス)

画像はNASAのテラ衛星が撮影したものである。洪水の画像は2016年1月3日に撮影され、洪水前の画像は1年前の2015年1月10日に撮影されたものである。

洪水前（2015年1月10日）

洪水（2016年1月3日）

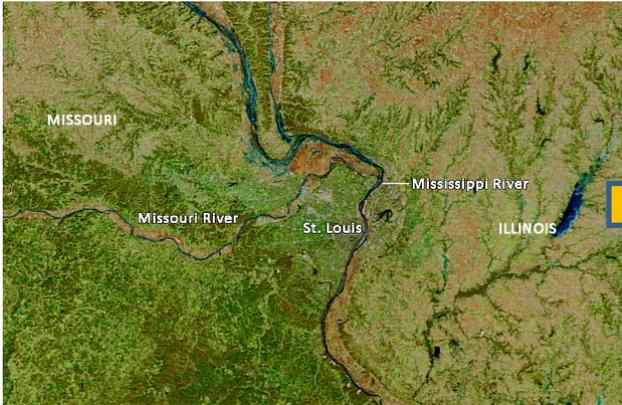
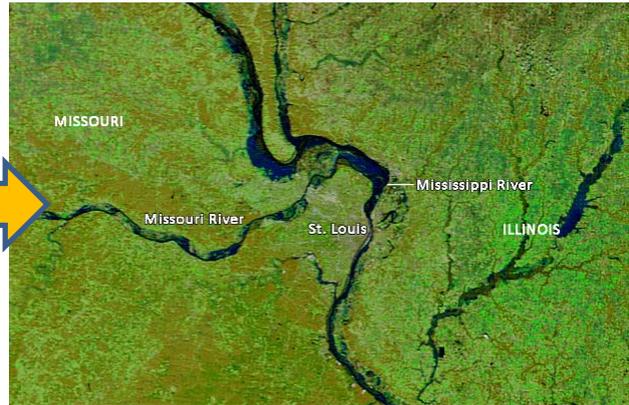
拡大画像1 (セントルイス周辺)

洪水前 (2015年1月10日)

洪水 (2016年1月3日)

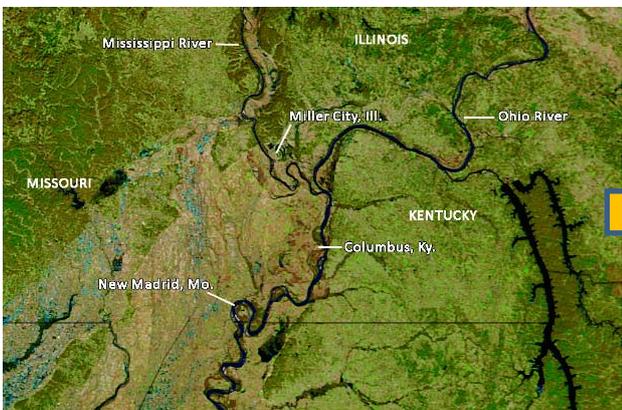
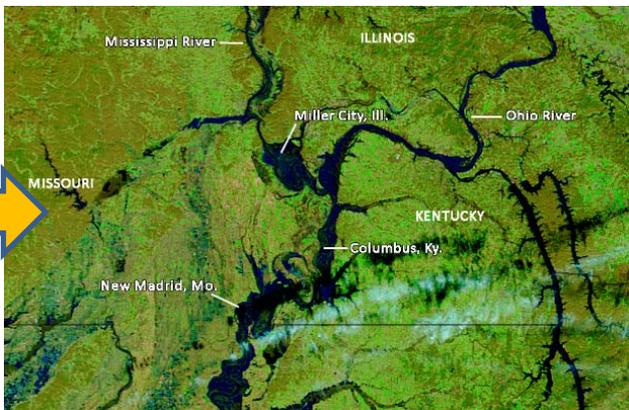
拡大画像2 (ミラーシティ周辺)

洪水前 (2015年1月10日)

洪水 (2016年1月3日)

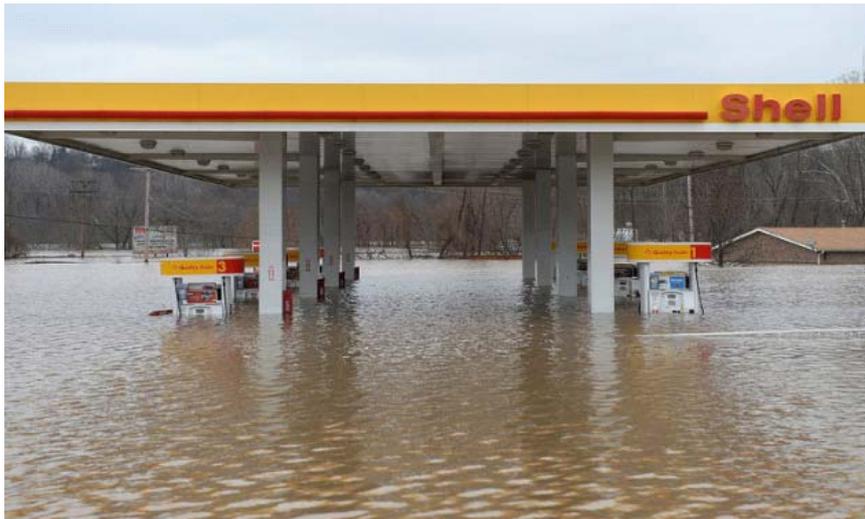
写真1

A submerged gas station on Route 141 in Fenton, Missouri, on Dec. 30 2015

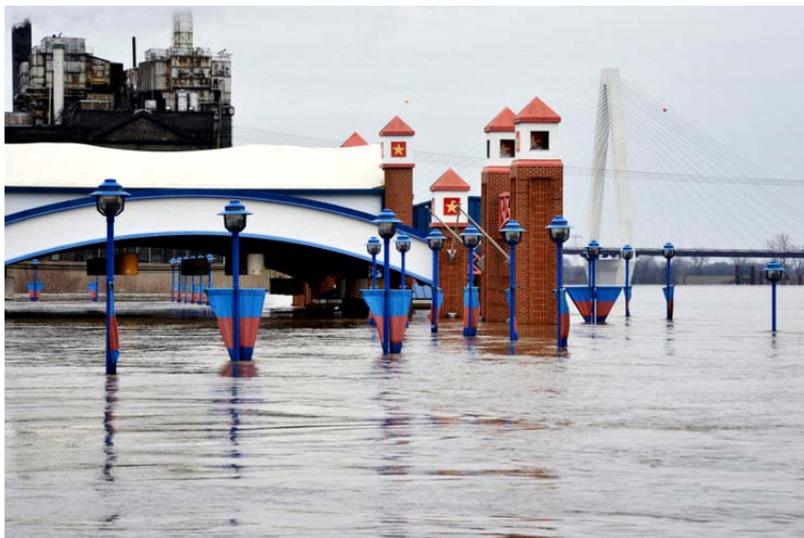
写真2

The Mississippi River is pictured flooding parts of downtown St. Louis, Missouri, Dec. 31 2015

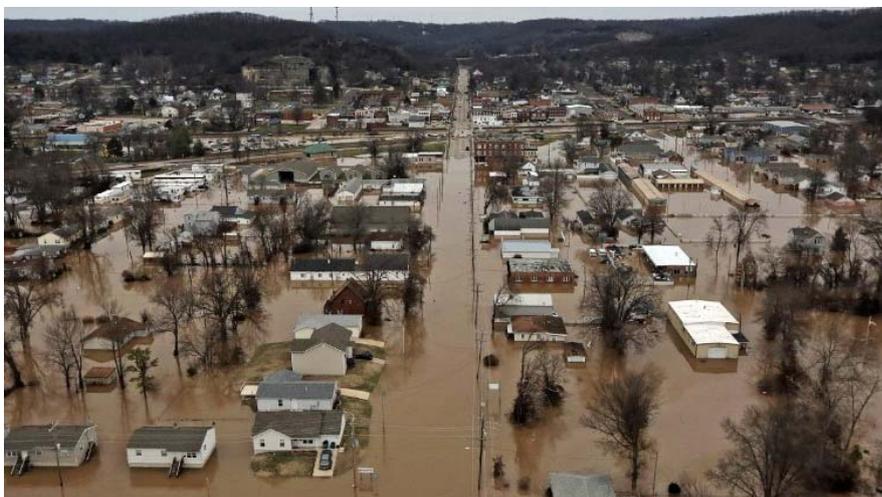
写真3

This photo shows a northern view of 1st Street where homes were flooded in Pacific, Missouri Dec. 29, 2015

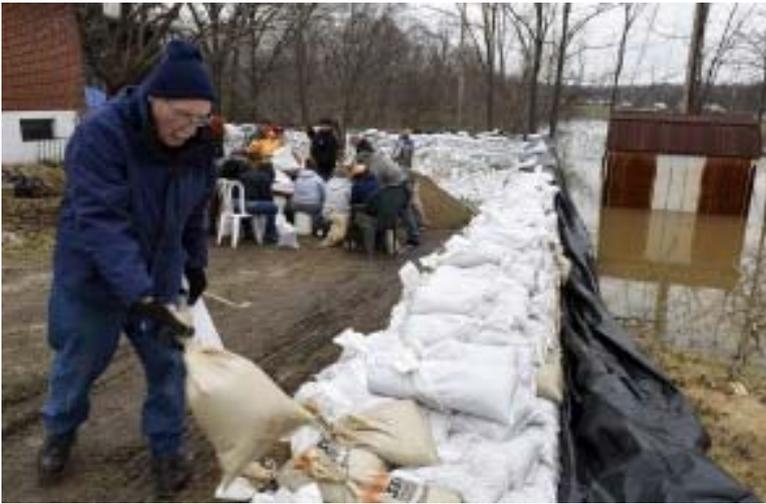
写真4

Volunteers create a wall of sandbags to protect homes from flooding after several days of heavy rain in Arnold, Missouri on Dec. 30, 2015

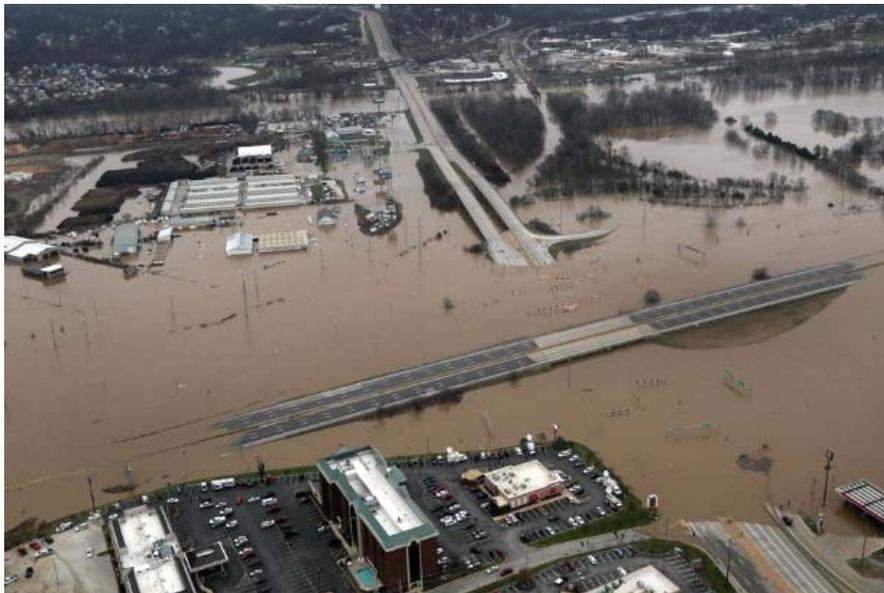
写真5

An aerial view from a Missouri National Guard UH-60 Black Hawk helicopter shows the effects of flooding in Pacific, Mo., Dec. 30, 2015.

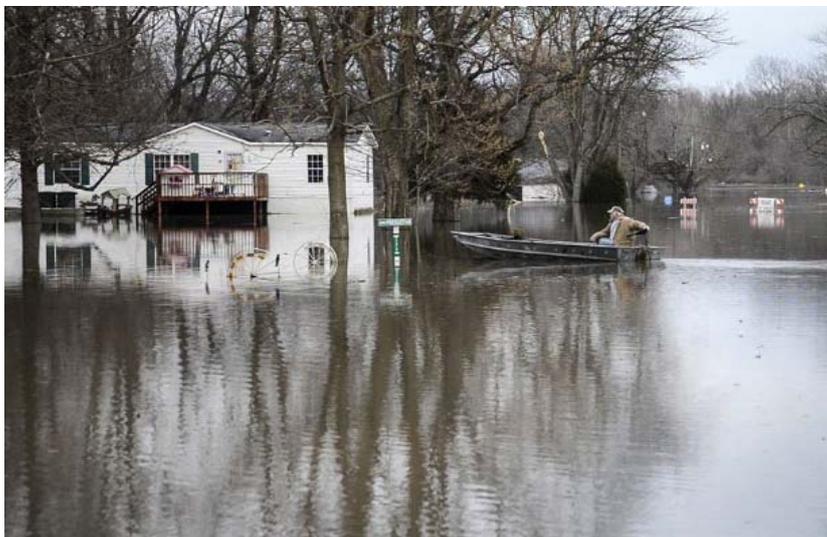
写真6

A resident rides his boat through flood waters to check on his home in Commerce, Mo., Dec. 31, 2015.

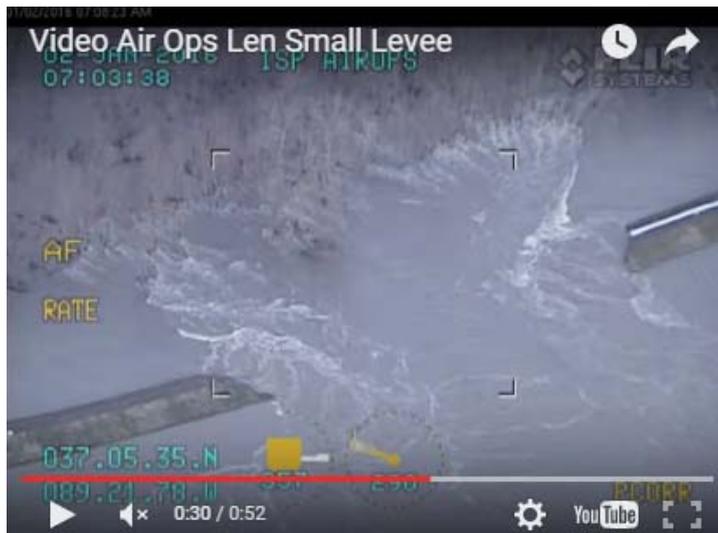
写真7

Flyover of a levee breach west of Miller City in Alexander County. The video shot by the Illinois State Police at 7:00am on Jan.2, 2016

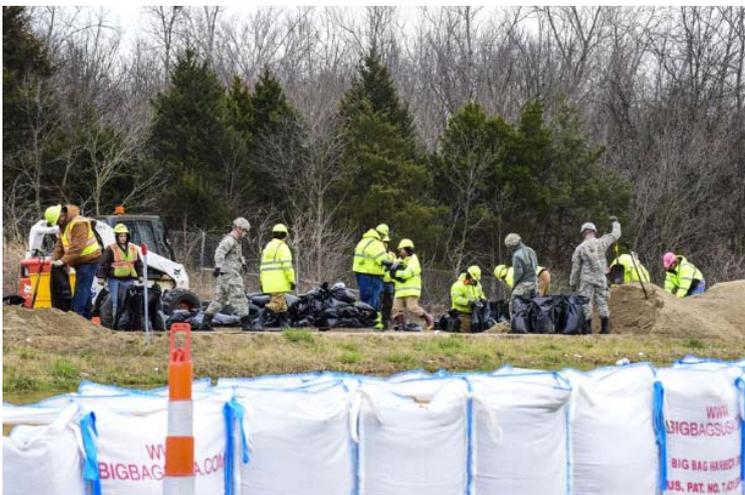
写真8

Army combat engineers fill sandbags to help Missouri's Transportation Department workers in Arnold, Mo., Dec. 31, 2015. The engineers are assigned to the Missouri National Guard's 220th, 880th and 1138th engineer companies.

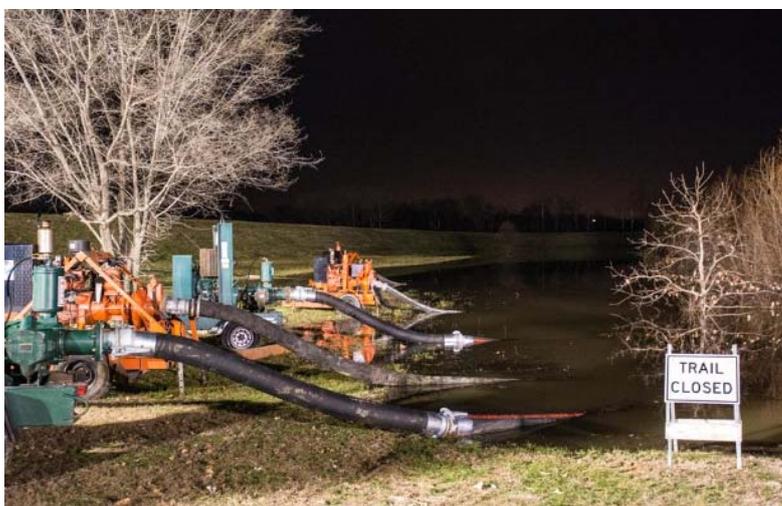
写真9

Water is pumped out of the affected areas back over the Valley Park levee on the Meramec River in Missouri, Dec. 31, 2015. Soldiers and airmen assigned to the Missouri National Guard volunteered to support the Missouri Department of Transportation in flood relief efforts in south-central Missouri. The focus of the aid is to ensure traffic control, water purification and levee reinforcement in affected areas.

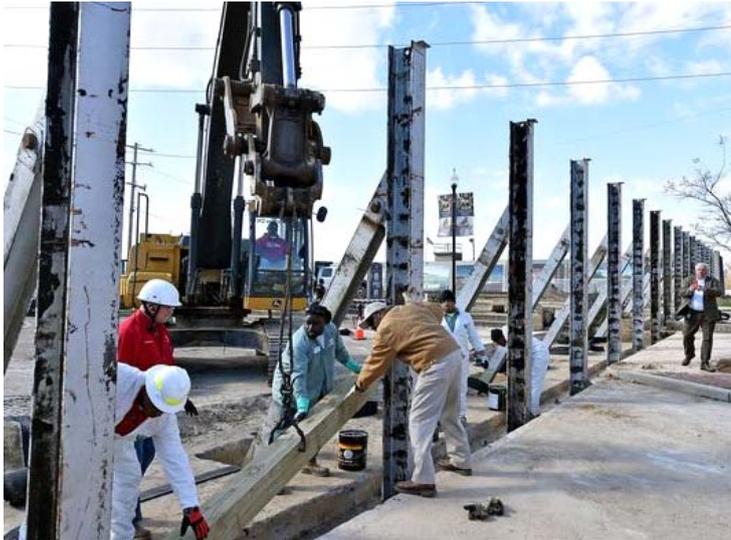
写真10

City of Vicksburg employees work on a floodwall Wednesday near the Old Depot Museum on Levee Street in Vicksburg as the Mississippi River continues to rise. Jan.6, 2016
