GROYNE TO PREVENT RIVERBANK EROSION ON MEKONG RIVER

Hirotsada MATSUKI, Dr.Eng.

Ministry of Land, Infrastructure, Transport and Tourism (1997-2000 JICA Expert for Laos)

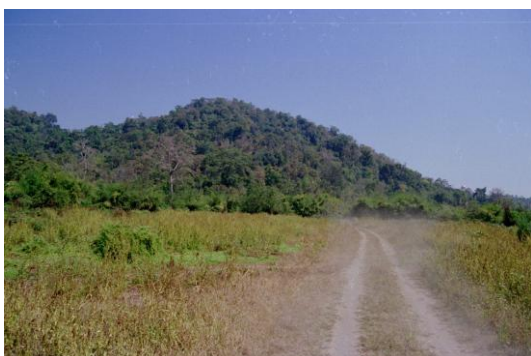
As a result of investigation trips, a triangular hill was discovered in 10 km north form the village (Photo 4). It was an outcrop of less weathered granite with 2.8 in the density. The rock was minable and transportable by local workers who had experience of road construction.

Photo 8 Small triangular hill of granite (February 1998)

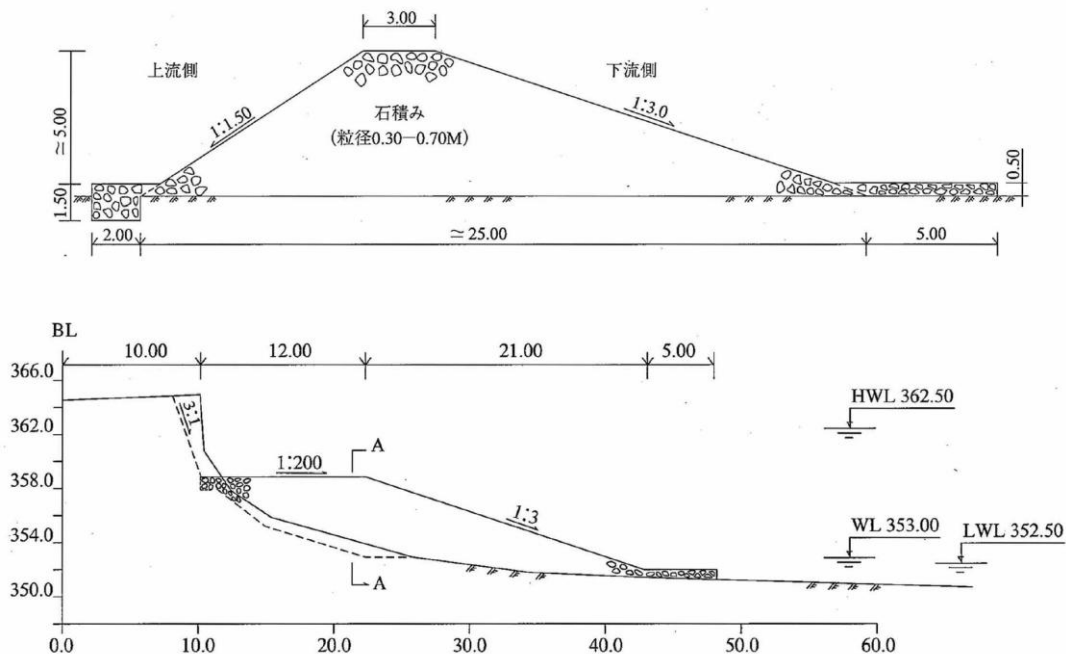
Fig.4 Side view and cross-section of standard masonry groyne

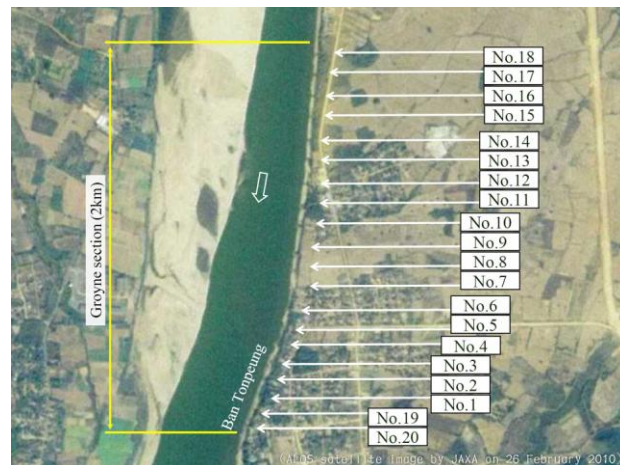
After the groyne project, Ban Tonpeung were inundated twice by bank-full floods in 2002 and 2008⁷). The masonries were submerged completely and provided opportunities to accelerate deposition. The situation in February 2010 could be checked in the satellite image (**Fig. 5**).

Fig. 5 Work sequence of 20 groynes
(ALOS satellite image by JAXA on 26 February 2010)
