Fukui Torrential Rain in July 2004

- Kinki Regional Development Bureau, Ministry of Land, Infrastructure and Transport and Fukui Prefecture: *Disaster by Fukui Torrential Rain in July 2004 (prompt report)*

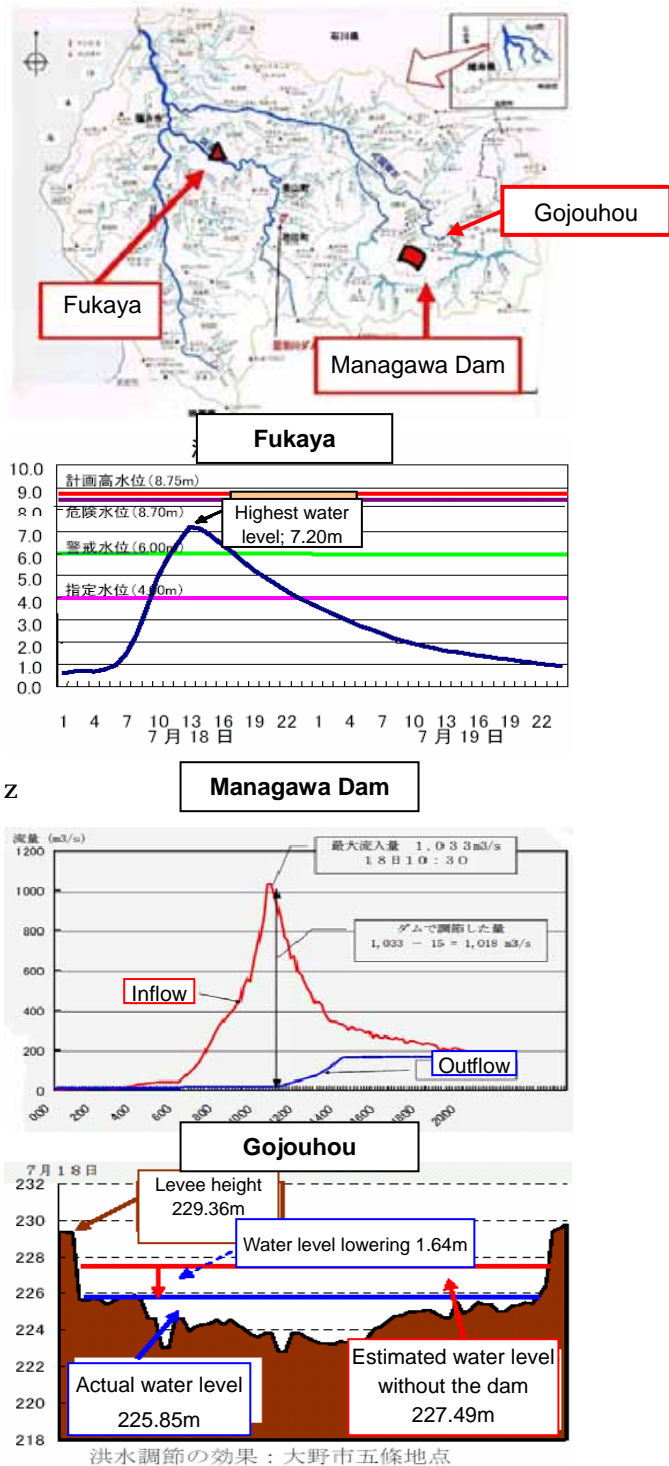
The dam regulated flood flow and the difference between inflow and outflow was about 1,000m³/s at the maximum, and it lowered the water level of the downstream.

Without the dam, it is assumed that the water level might have reached just 1.87m below from the levee crest at Gojohou in Ono city (The highest water level recorded: was 2.35m at 16h00 of 18th).

The dam contributed to bring the water level down by about 1.64m.

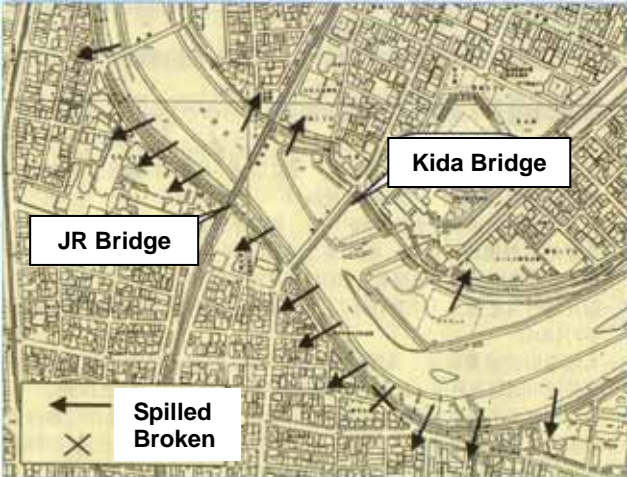
Spots of the spill from the levee and the levee failure.at JR bridge and near Kida bridge

Most damage of Fukui torrential rain was caused by water spilled from a levee or flow from a broken dyke. Especially, the heaviest rain in the recent years caused flood near the JR Bridge and the Kida Bridge in Fukui city, and brought about a lot of damage in the city (According to the analysis by the urgent research of Japan Society of Civil Engineers in July, 2004, the decrease of cross-sectional area by bridge piers is assumed to be the cause of the spill and the dyke break).

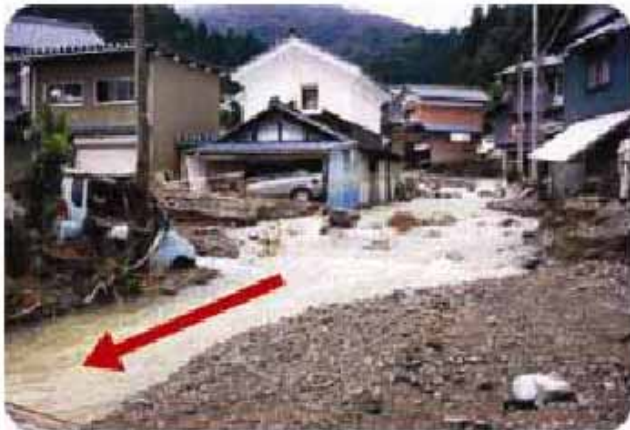
Debris flow

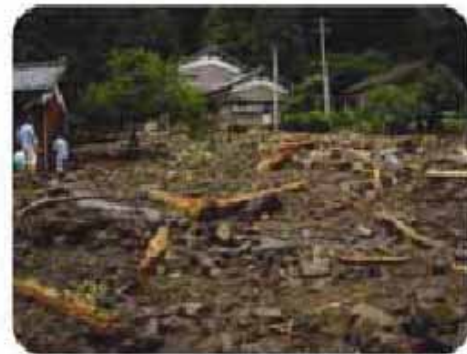
Debris flow

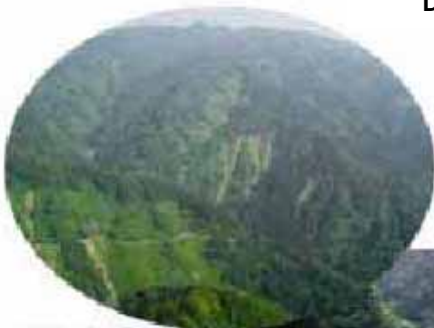
福井市一乗谷川源流付近
崩壊箇所が複数見られる

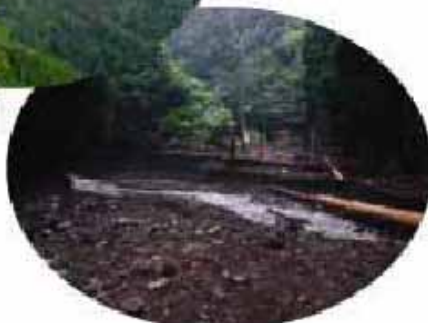
Debris flow

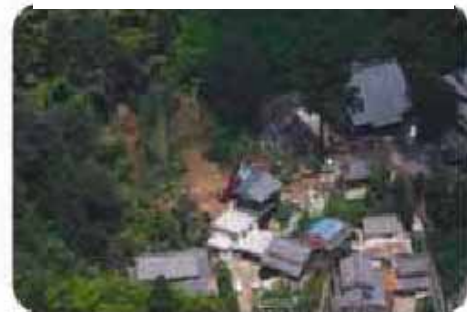
Landslide

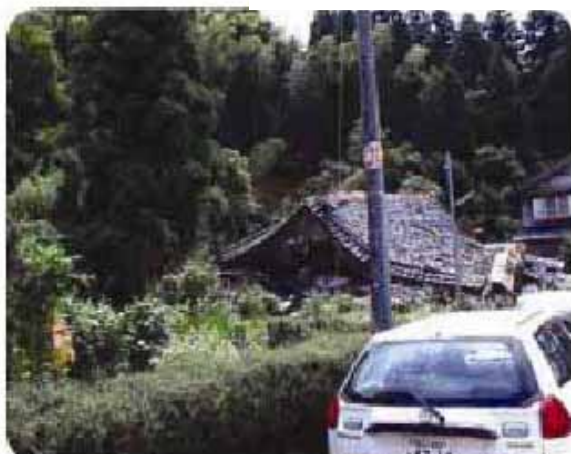
Landslide

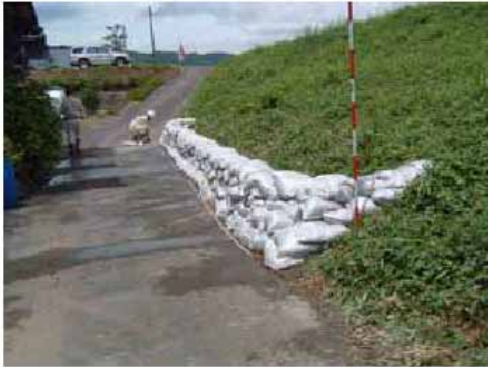
Shimizuchou, Katakasu : water leakage at the left bank of Hino River

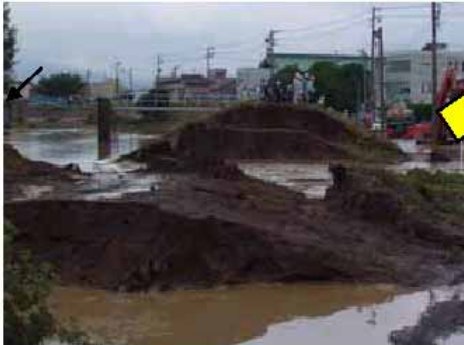
Dyke breaks (Asuwa River in Fukui district)
