The Application of Sabo Technology for Lahars Flood Mitigation and Warning System in Volcanic Area

**Agus Sumaryono
Bambang Sukatja
F. Tata Yunita**

SCOPE OF ACTIVITIES

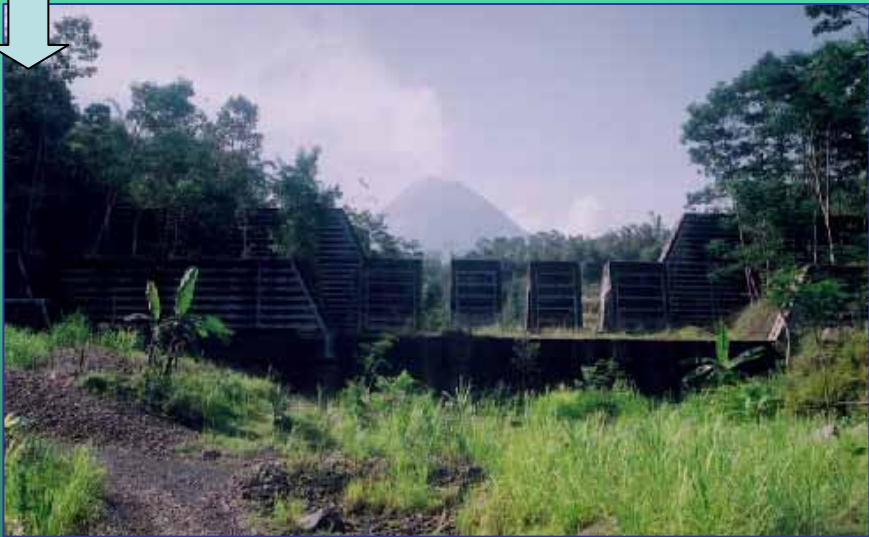
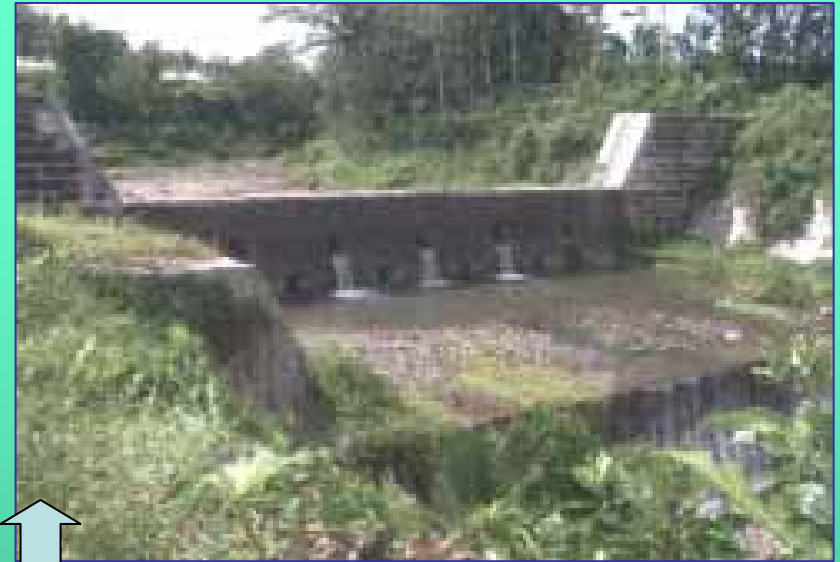
BO-D5, Slit Type Check dam

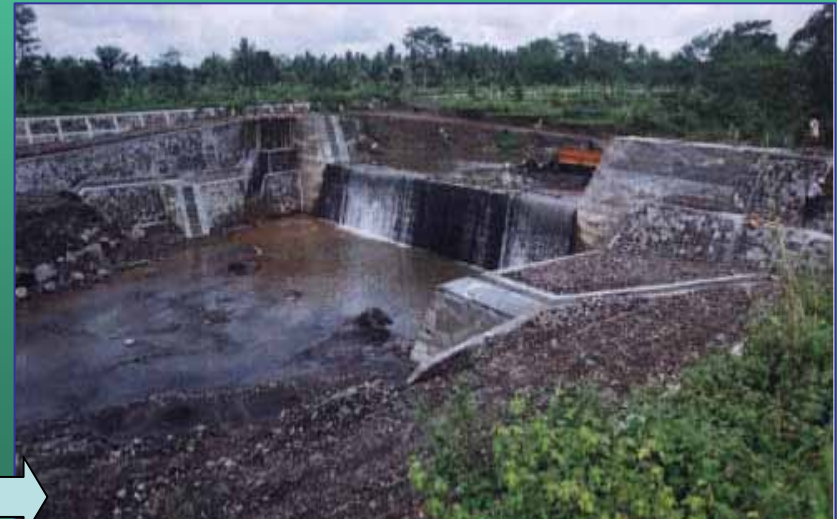
BO-D1, Conventional Type Checkdam

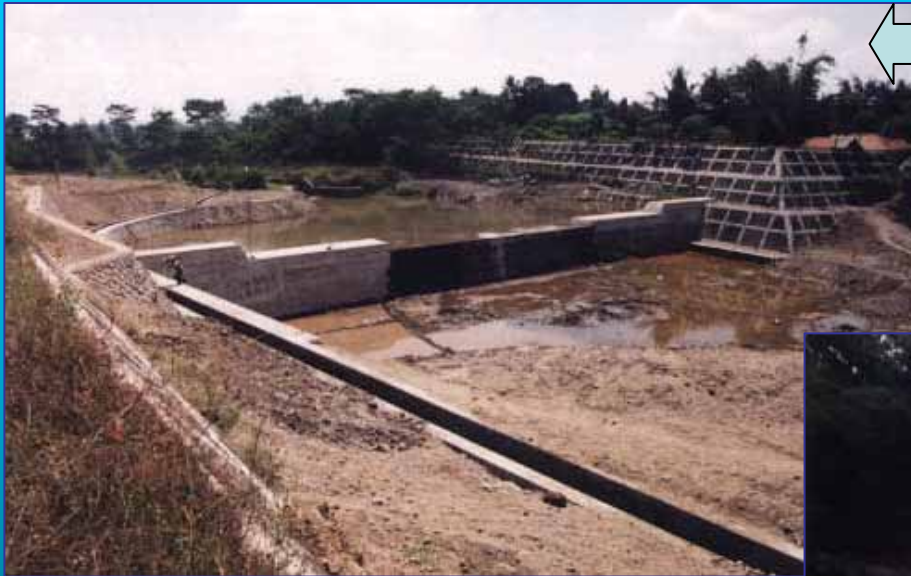
BO-C12, Consolidation Dam

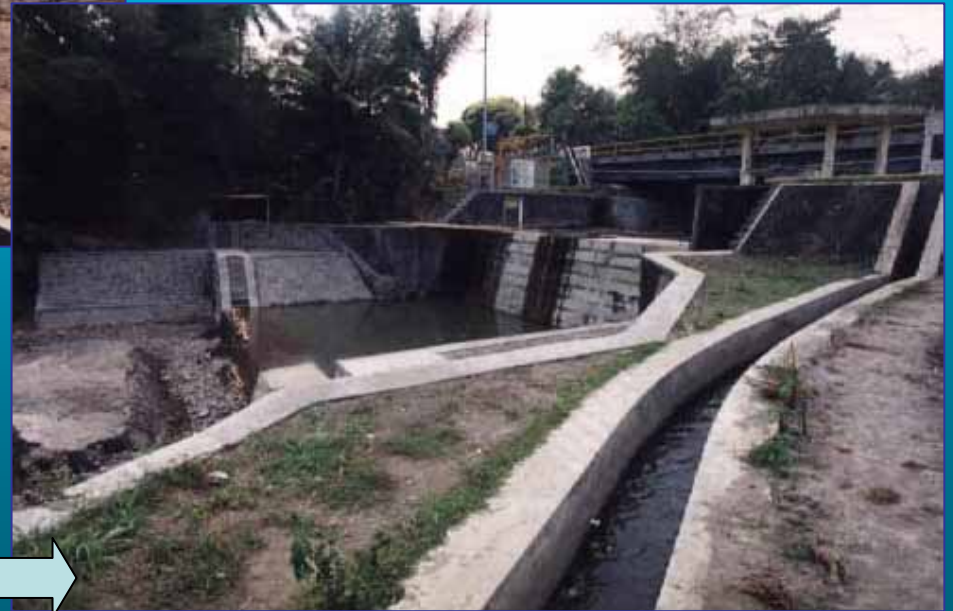
BO-GS2B, Groundsill

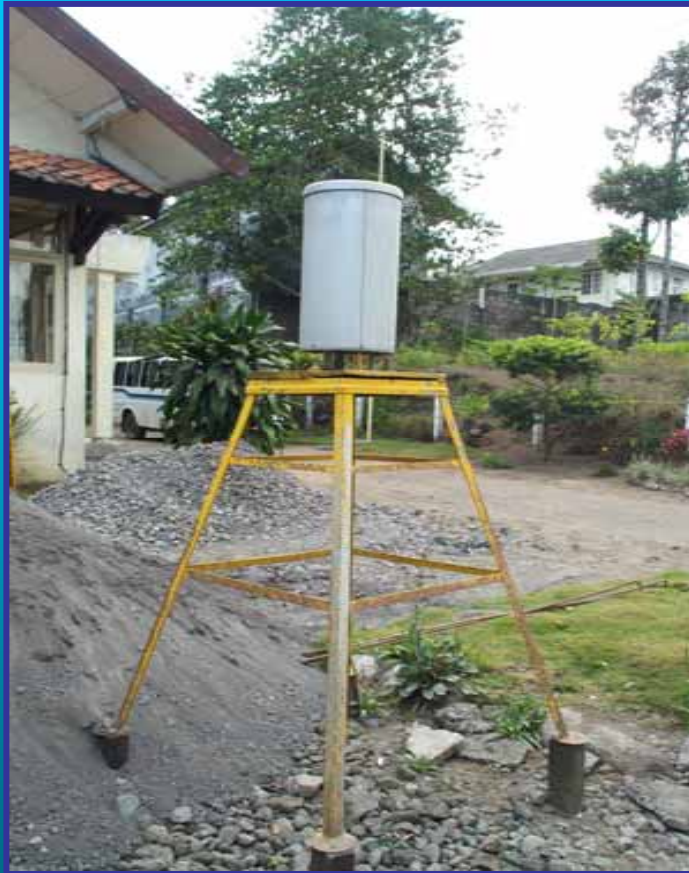
Automatic rain gauge
in Kaliurang

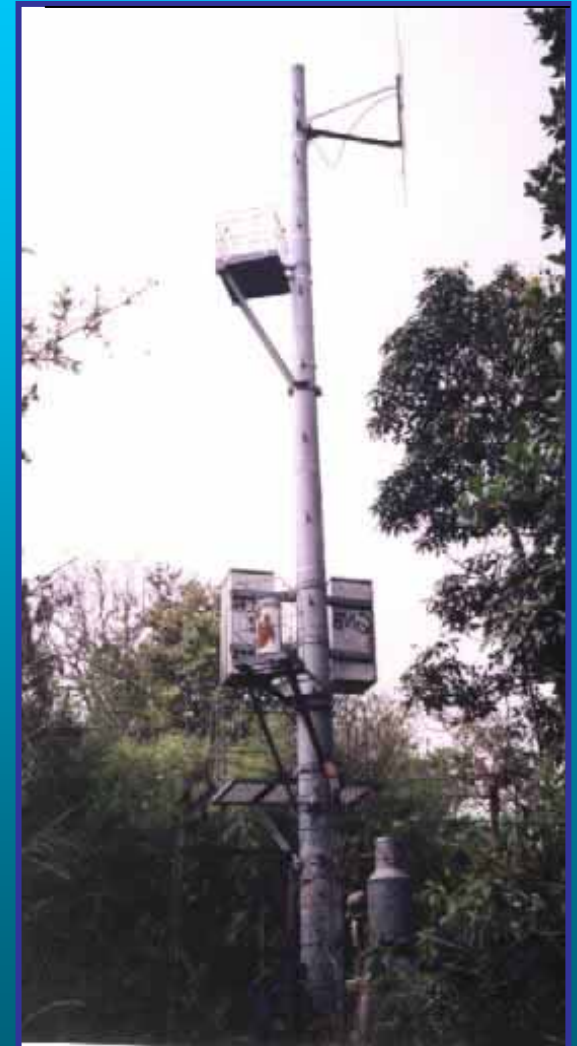
Telemeter System of
Automatic Rain
Gauge in Plawangan

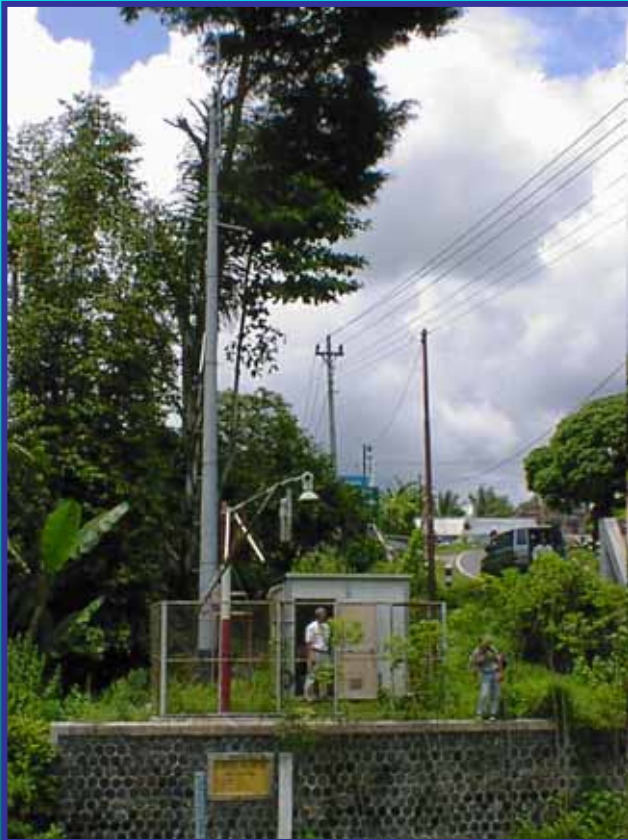
**Automatic Water Level Gauge
in Pulowatu**

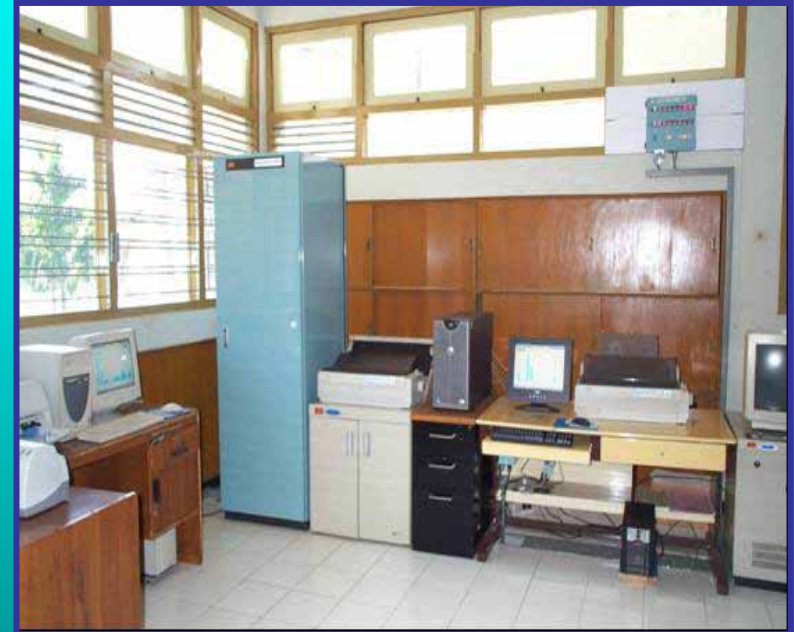
**Control Room of
Telemeter System in
Experimental Station
for Sabo in Yogyakarta**

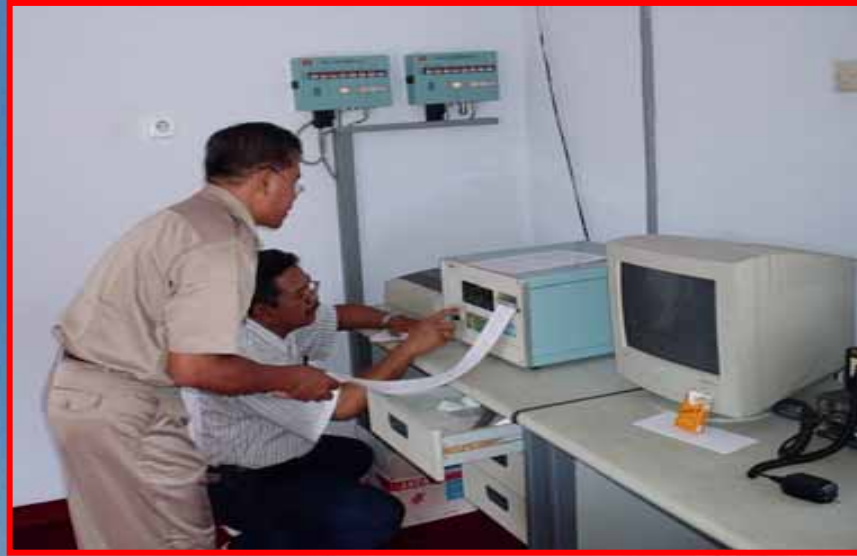
Main Control Station of Lahars Warning System in Lumajang

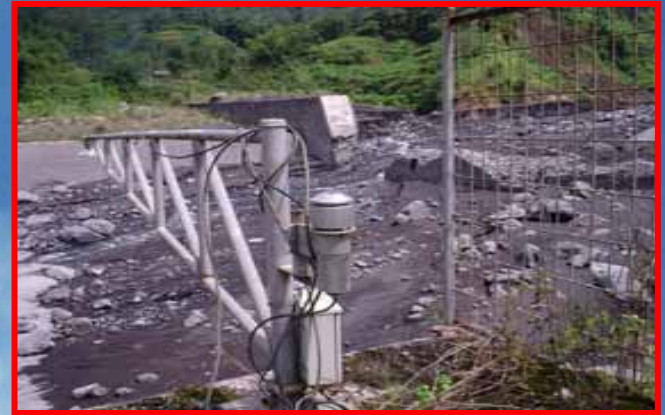
Telemeter System of Automatic Water Level Recorder in Besuk Koboan River

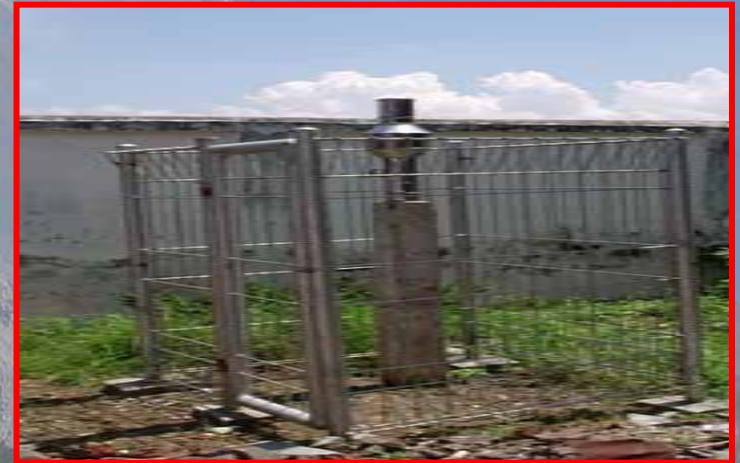
Non-telemeter Automatic Rain Gauge in Mujur River Catchment Area

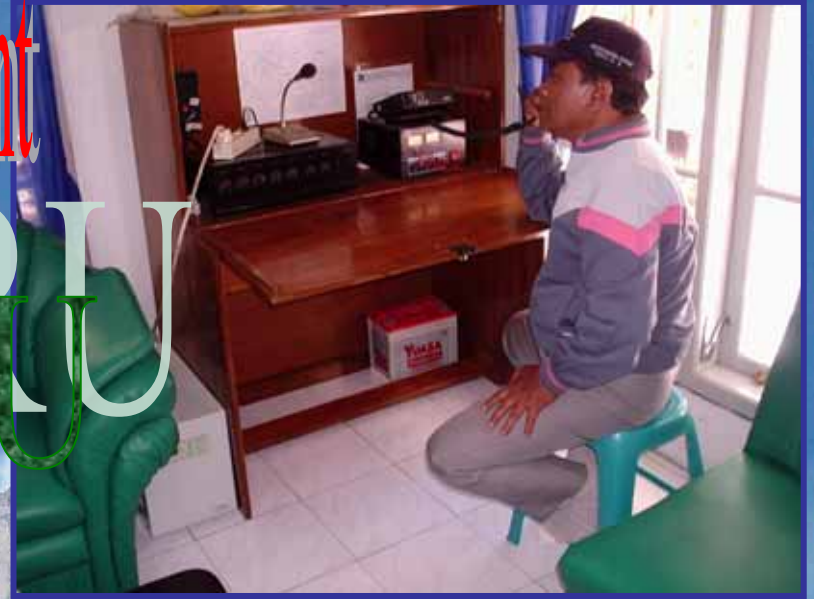
Radio and Siren Equipment at Station of Warning System

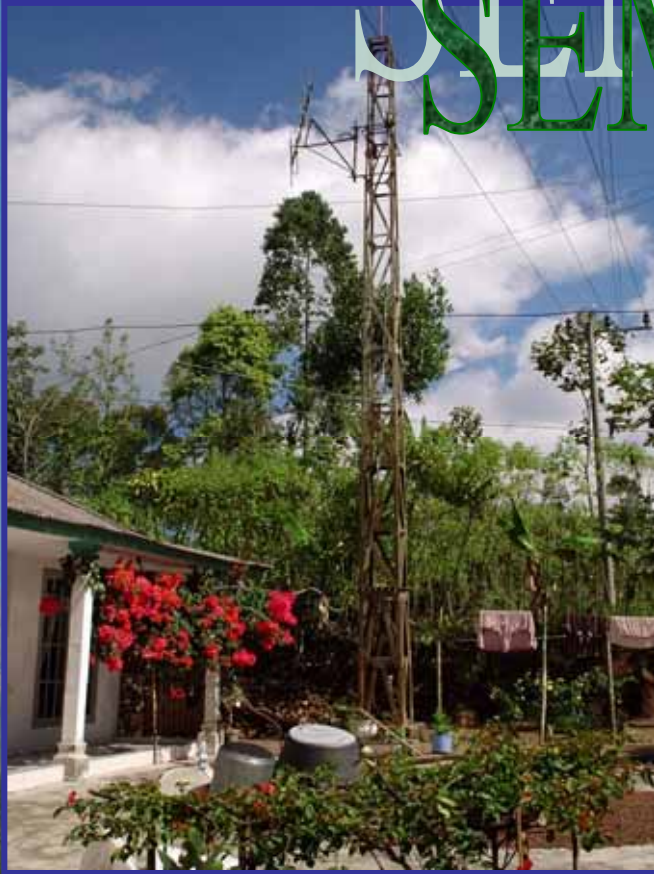
Station of Lahars Warning System in Lumajang

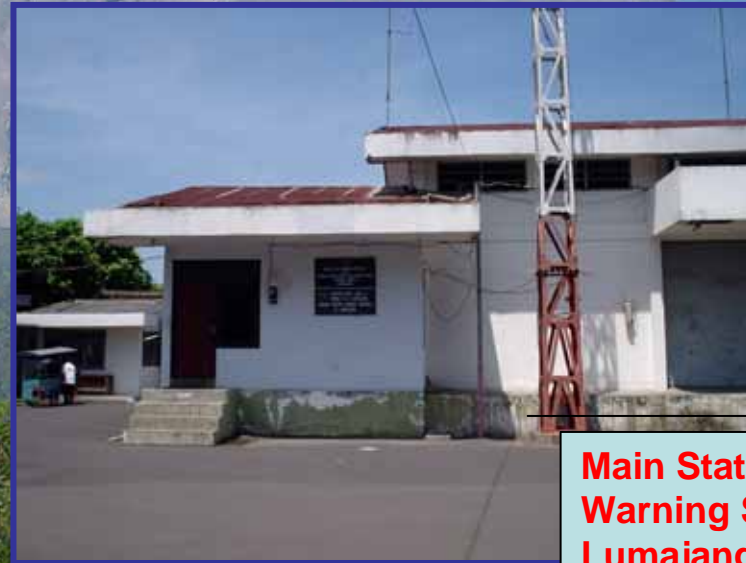
Main Station of Lahars Warning System in Lumajang
