## ブラジル 豪雨による洪水被害

場 所	ブラジル連邦共和国 北東部 Bahia州Lajedinho	死者※	16名
発生日	2013年12月7～8日	行方不明者※	1名
概 要	2013年12月7日～8日にかけて、旱魃被害に直面していたブラジル北東部のBahia州Lajedinhoで短時間の豪雨により洪水が発生し、死者16名、行方不明者1名となった。

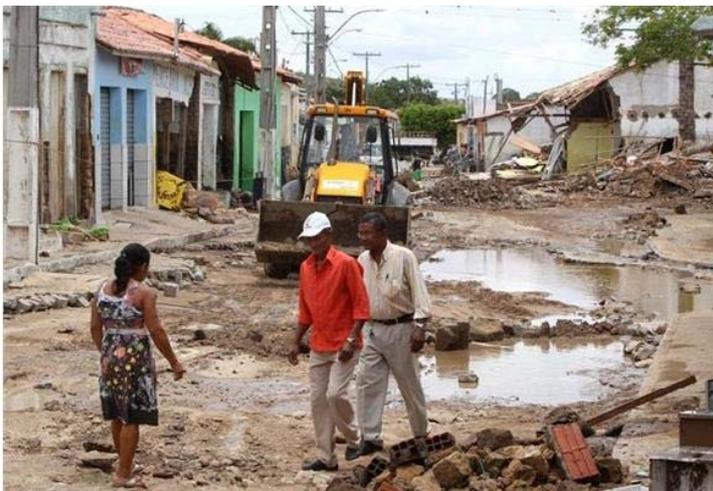
写真1

In this photo released by Bahia government, people walk on a flooded street in the Lajedinho municipality, Bahia state, Brazil, Monday, Dec. 9, 2013.

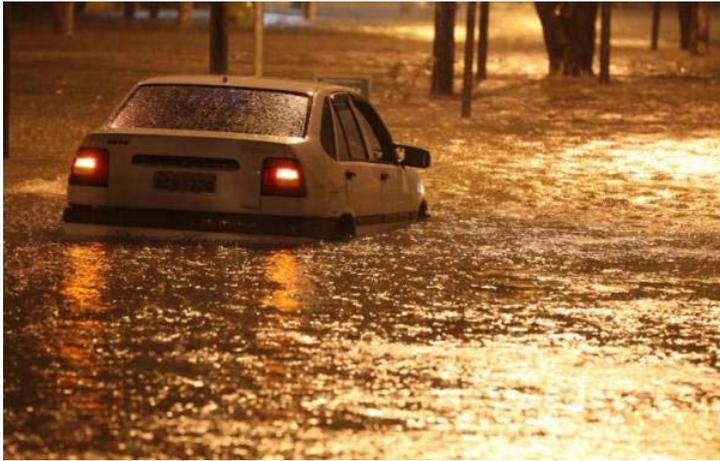
写真2

File: Some 70 homes were completely destroyed and 200 others damaged in the town of Lajedinho during a violent weekend storm, the spokesman said. Picture: LUIZ GUARNIERI/ BRAZIL PHOTO PRESS.

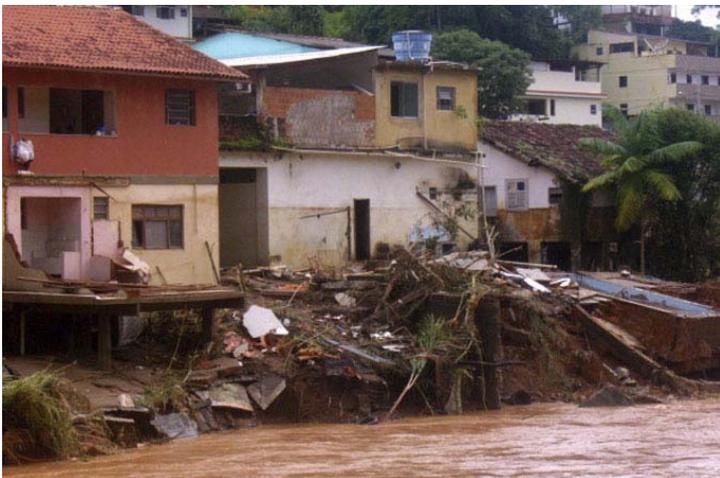
写真3

Over 70 houses were destroyed and around 200 people had to seek shelter in eastern Brazil [Getty Images]
