インド 豪雨による地滑り被害

| 概 要 | モンスーンによる豪雨で大規模な地滑りが発生し、村1つがのみ込まれた。死者数は151名にのぼる。 | | |

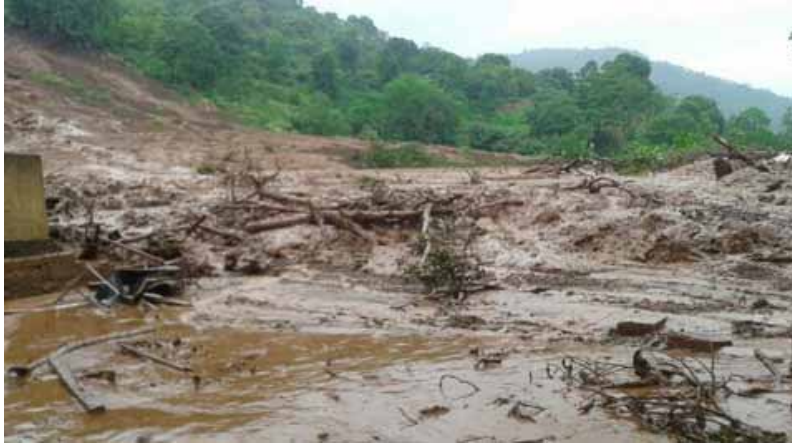
写真1

After a landslide in Malin village in ambegaon taluka in Pune district, about 80 km from Pune.

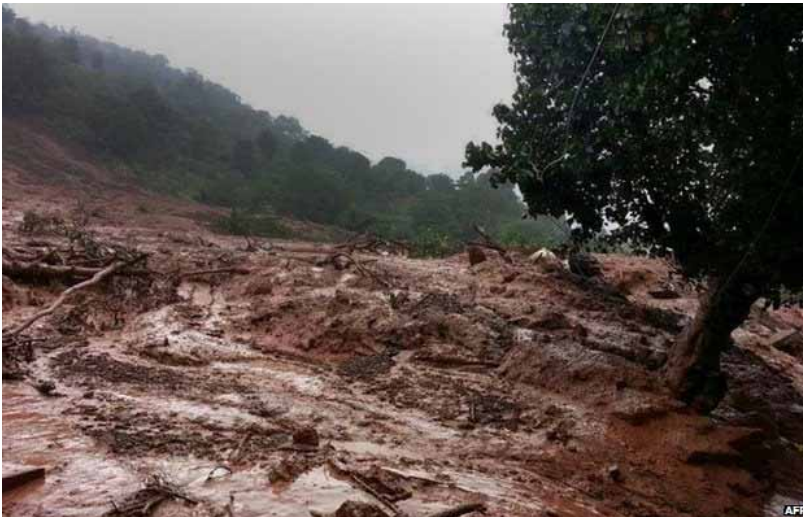
写真2

The landslide spot in Pune district, 30 July 2014
The debris from a hill near the village collapsed on homes

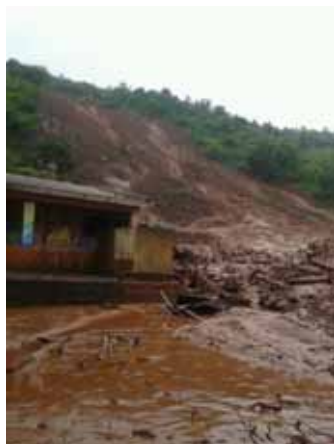
写真3

People living in about 35 houses have come under the debris of a hillock that caved in at village Malin in Ambegaon taluka of the district when they were asleep, Pune (rural) police said.

- 被災地域の住宅のほとんどが泥と草でできた掘っ立て小屋で、瓦礫に押しつぶされてしまい、地滑り発生時まだ寝ていた住民のほとんどは逃げることができなかった。
- 7月30日の報道によると、マリン村は僻地にあり、午前7:30過ぎに国営バスの運転手が村に到着し、初めて被害が明るみになった。その後、プネ地区当局が救援、救済活動を始め、国家災害対応部隊 (National Disaster Response Force, NDRF) が現場に向かったのは正午近くであった。
- 7月30日時点、国家災害対応部隊は、救助活動のため378名の隊員からなる9つのチームを派遣したが、降り続く雨が活動を阻んでいる。
- ムンバイ郊外では、昨年同様の災害が発生し、74名が死亡している。
