Bonnet Carré Spillway

**US Army Corps
of Engineers®**
New Orleans District

Introduction

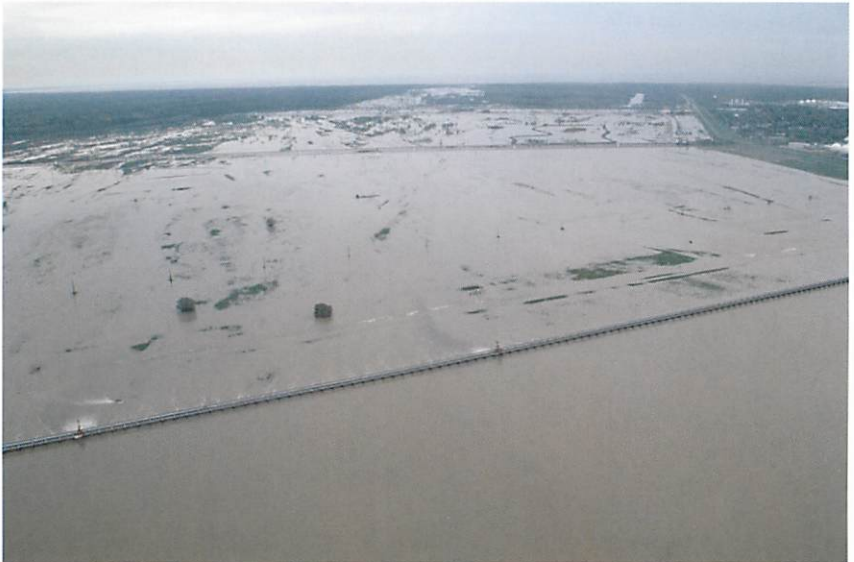
Map of Bonnet Carré Spillway (top), and aerial of the spillway in operation during the flood of 1975. The view is from the Mississippi River with Lake Pontchartrain in the background.

The Bonnet Carré Spillway consists of two basic components: a control structure along the east bank of the Mississippi River and a floodway which conveys the diverted floodwaters to the lake. The control structure is a mechanically controlled concrete weir which extends for over a mile and a half parallel to the river. Confined by guide levees, the floodway stretches nearly six miles to Lake Pontchartrain.

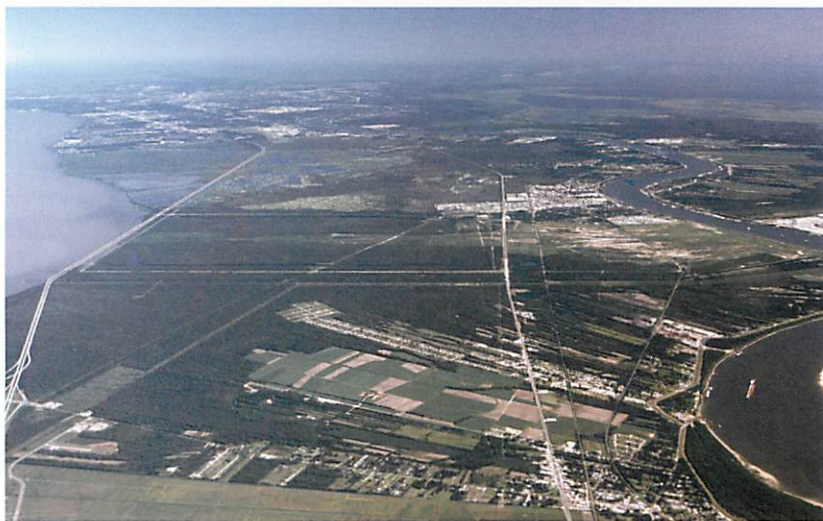
High altitude view of the spillway (center) stretching from the Mississippi River to Lake Pontchartrain, looking down river.

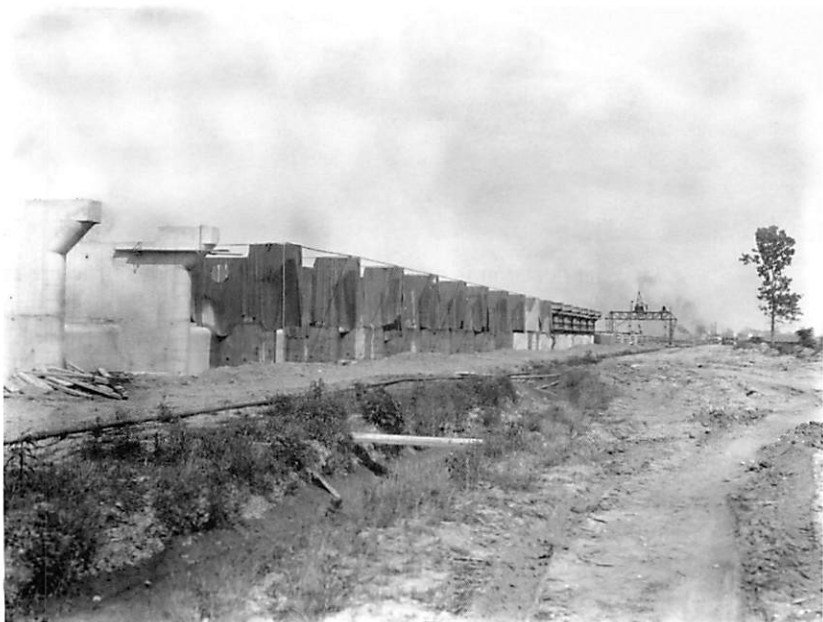
High strength concrete used in the spillway was an engineering advancement.

Because of the large quantity of concrete involved in the structure (135,000 cubic yards), it was essential that the concrete mixture produce strong, durable and economic concrete. The Corps established a concrete laboratory to determine optimal mixes of sand, gravel, cement and water quality for the spillway. Tests from the lab proved critical, resulting in a very high strength concrete in the neighborhood of 5,000 pounds per square inch. This was a significant advancement for the time, as typical concrete in the 1930s provided only 2,500 to 3,000 pounds per square inch compressive strength.

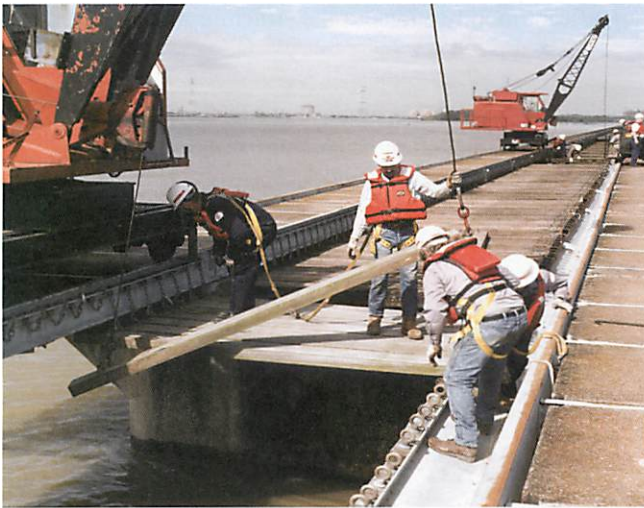
In opening the spillway, each timber is individually lifted and placed atop the structure.

Once the decision is made, actual operation of the structure is relatively simple. Two cranes, which move along tracks atop the structure, are used to individually lift each timber from the required number of bays. The timbers are raised from their vertical position across the weir opening (where together they serve as a dam against the high water) and are laid horizontally on top of the structure for later use in its closing. A complete opening of all 350 bays requires about 36 hours to lift the 7,000 wooden timbers in the structure. If a quicker opening of the structure is ever required, emergency procedures can release 20 timbers at a time and reduce the opening to three hours.
